WEEKLY CONSTRUCTION PROGRESS AND INSPECTION REPORT

Period Ending
August 19 th , 2016 Weekly # 30
Project AIP Number
3-49-0037-032-2015

Airport Name Vernal Regional Airport (VEL)					
Project Description Earthwork and Drainage	Contractor's Name J. Wright Companies				
1. Rough Estimate of Percent Completion to Date of Construction Phases <i>(Include items such as clearing, grading, drainage, base, surface, lighting, etc.)</i> "Notice to Proceed" issued November 2, 2015 Total Project Complete: 73% See attached Percent Complete spreadsheet.					
2. Work Completed or in Progress this Period. Resumed installation of ST-B at approx. STA 40+36 and tied into previously installed ST-B at MH ST-B2. Crew completed ST-B run and tie in on 8/17. Scrapers and rollers continued embankment placement from STA 12+00 to 18+00. BHI demoed conduit for the existing beacon to the existing handhole by Runway 7-25. BHI crew pulled home run cable from handhole to vault from this handhole. JWright crew worked on backfilling ST-B throughout the week, and started on ST-B 12" RCP lateral on 8/18. BHI worked on prepping parking lot patch for paving next week by scratching out the top 3" of material everywhere e

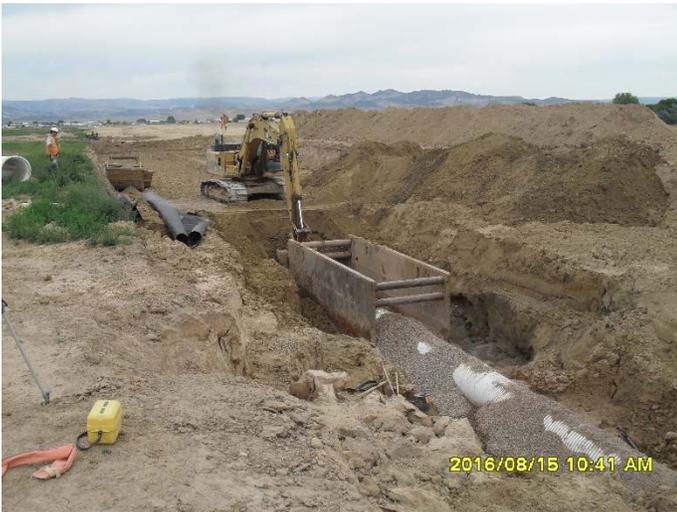
Installing ST-B (8/15)

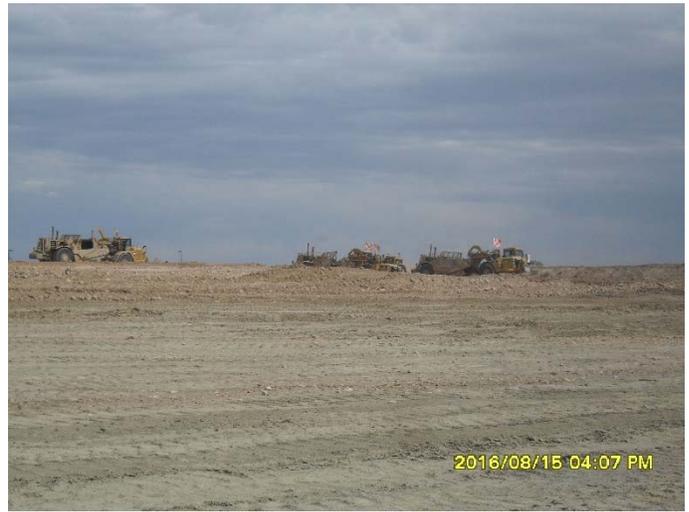
Scrapers moving material from cut (8/15)

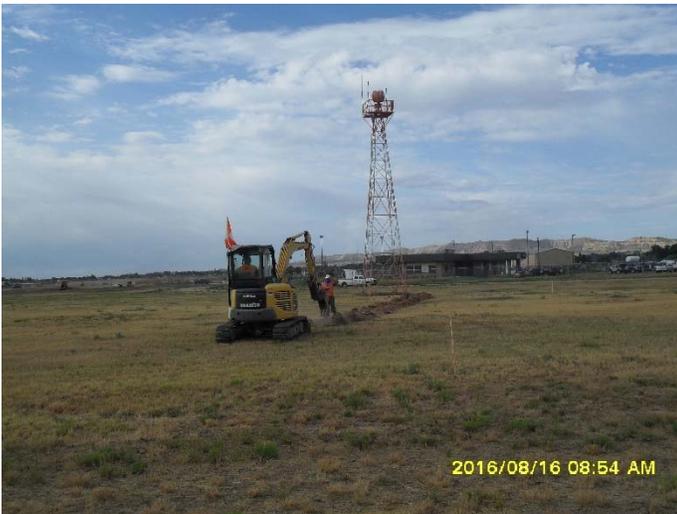
Demoing old beacon conduit/wire (8/16)

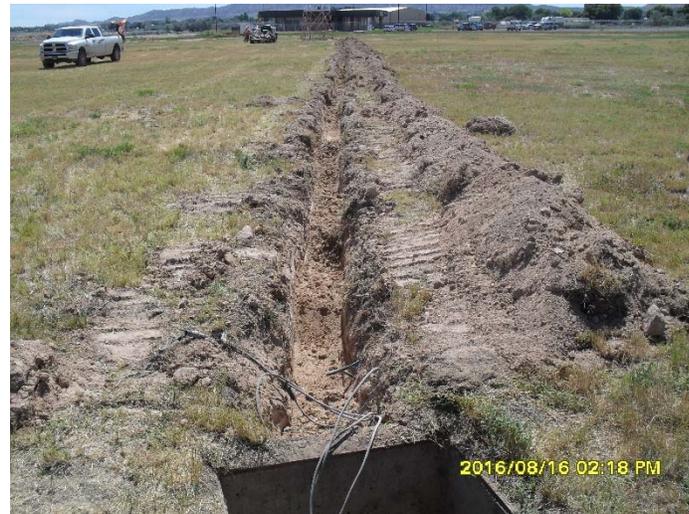
Demoing old beacon conduit/wire (8/16)

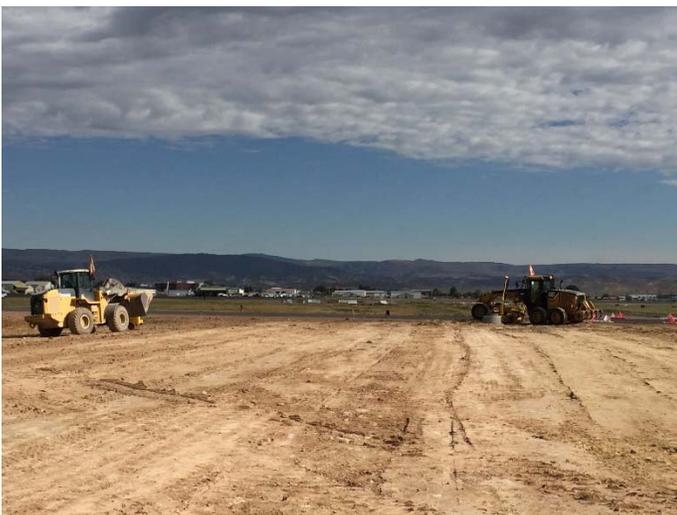
Grading embankment on north end (8/16)

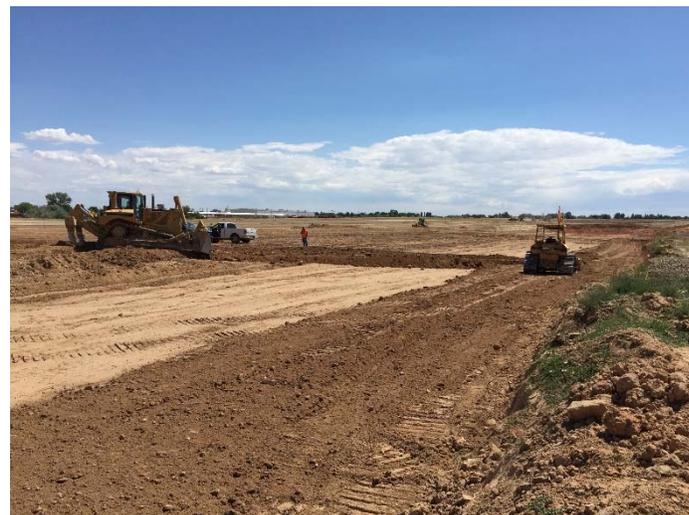
Backfilling/grading ST-B (8/16)

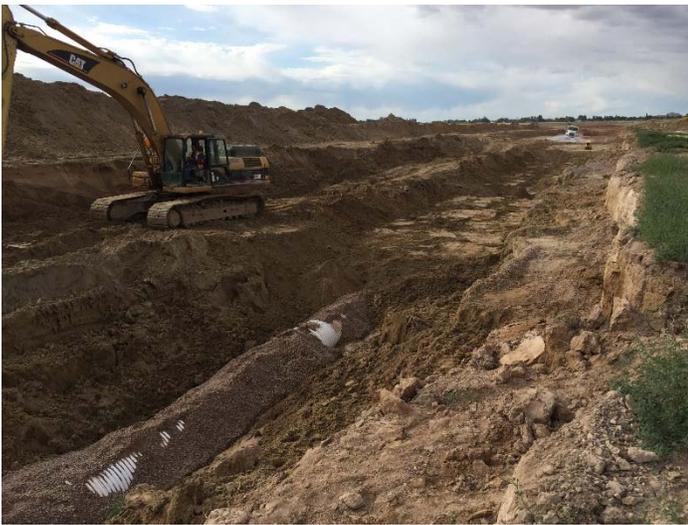
Backfilling ST-B (8/17)

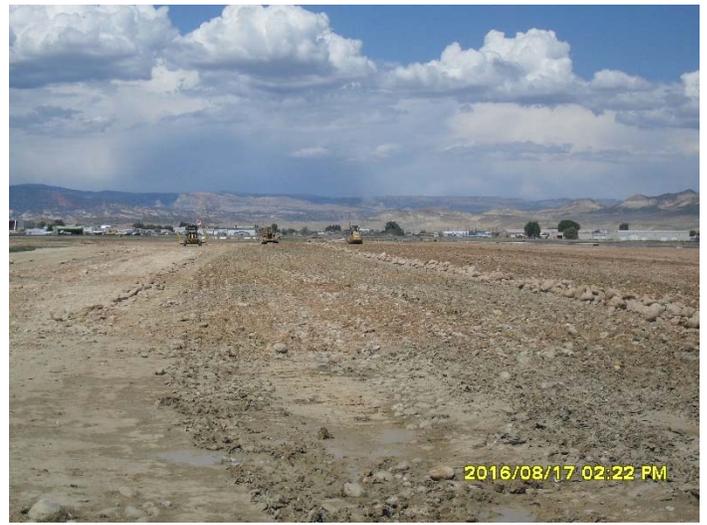
Placing embankment fill (8/17)

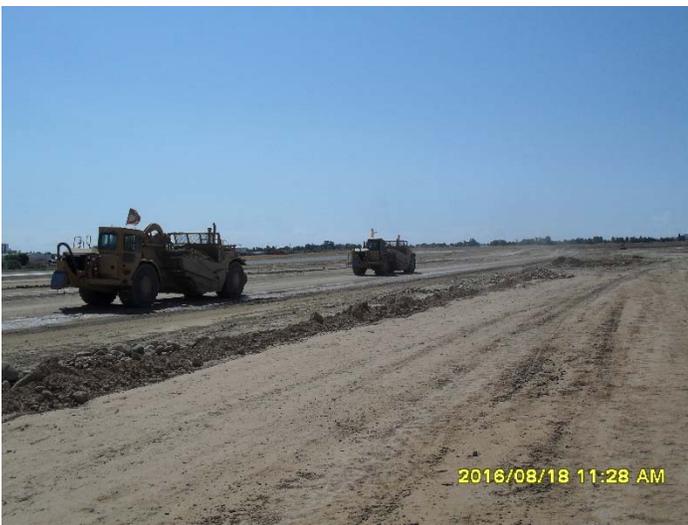
Scrapers hauling from cut to fill (8/18)

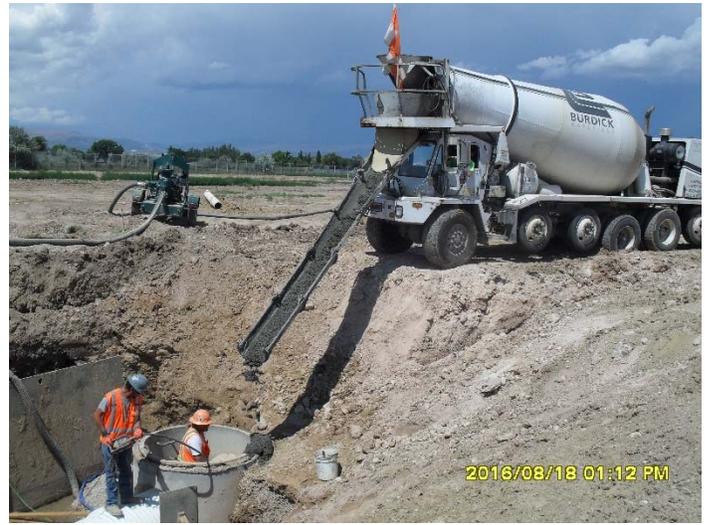
Pouring invert/collar for MH ST-B2 (8/18)

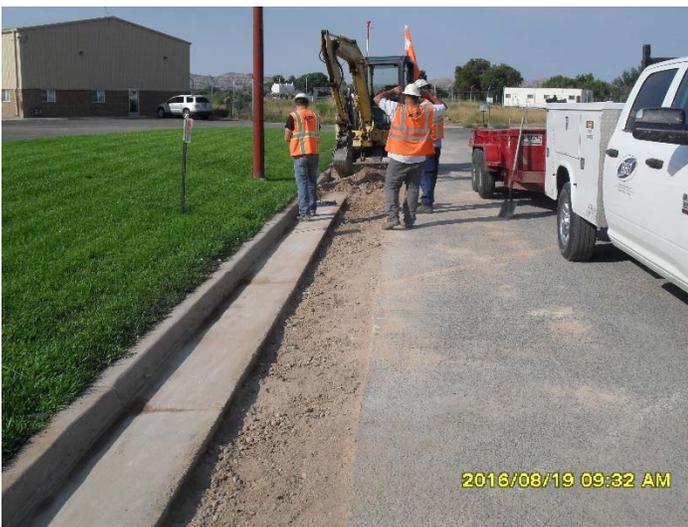
Prepping parking lot of paving (8/19)

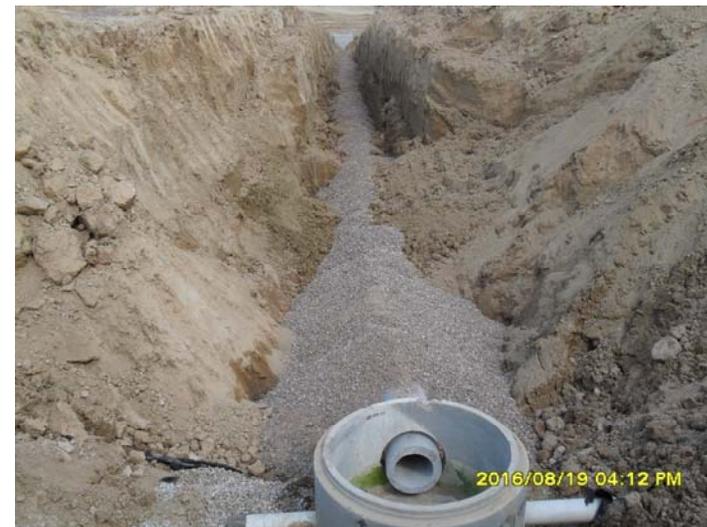
Installation of ST-B 12" RCP later (8/19)
