WEEKLY CONSTRUCTION PROGRESS AND INSPECTION REPORT

Period Ending
August 26 th , 2016 Weekly # 31
Project AIP Number
3-49-0037-032-2015

Airport Name Vernal Regional Airport (VEL)					
Project Description Earthwork and Drainage	Contractor's Name J. Wright Companies				
<p>1. Rough Estimate of Percent Completion to Date of Construction Phases <i>(Include items such as clearing, grading, drainage, base, surface, lighting, etc.)</i></p> <p>"Notice to Proceed" issued November 2, 2015</p> <p>Total Project Complete: 75%</p> <p>See attached Percent Complete spreadsheet.</p>					
<p>2. Work Completed or in Progress this Period.</p> <p>Scrapers placed embankment fill on east slope from approx. STA 40+00 to 15+00 and on centerline from approx. 25+00 to 15+00. Scrapers also worked on stripping topsoil behind 10" irrigation line so that material may be cut from there. Worked on backfill on ST-B from MH ST-B2 to next two manholes downstation as well as on the 12" RCP lateral for ST-B. BHI crew (using Allred Paving and Rotomill) paved parking lot patch where beacon duct run was installed and disposed of old temporary ASOS antenna (has not been used since ASOS moved) off-site, and tore down exist

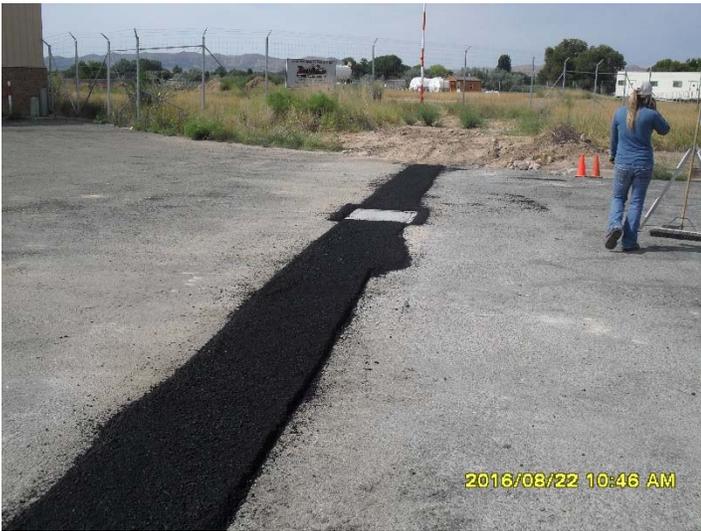
Paving parking lot patch for duct run (8/22)

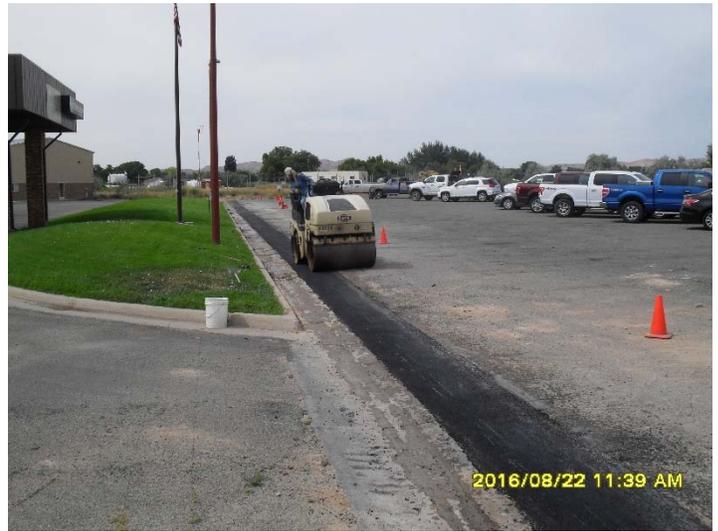
Paving parking lot patch for duct run (8/22)

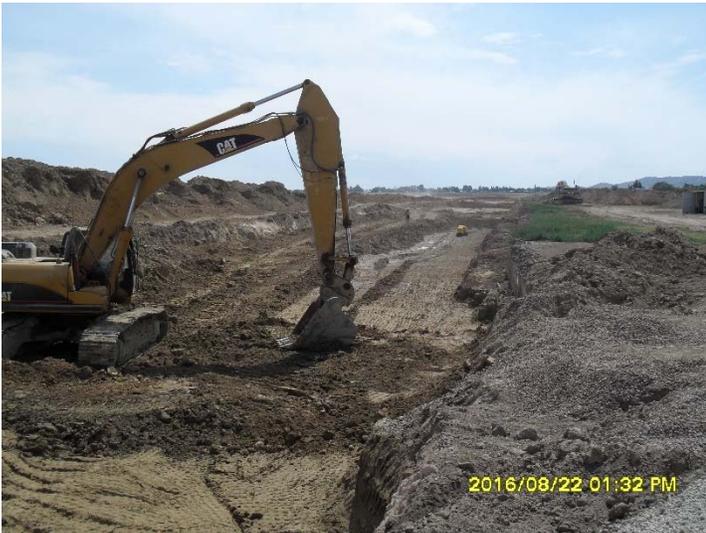
Backfilling ST-B (8/22)

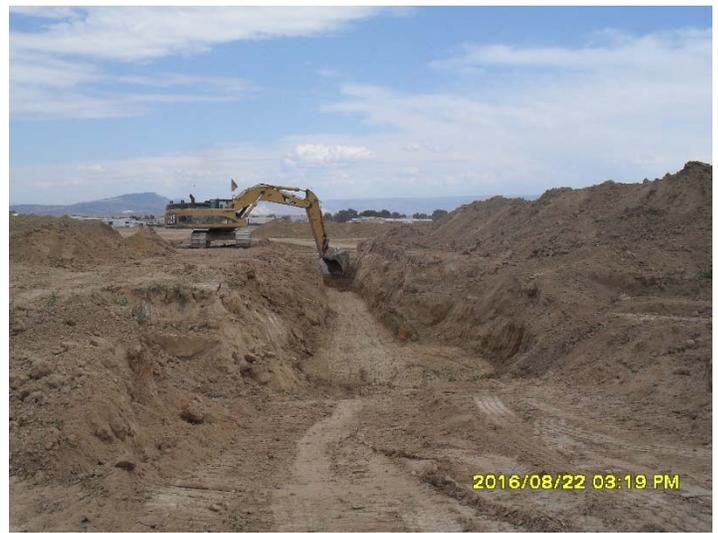
Backfilling ST-B lateral (8/22)

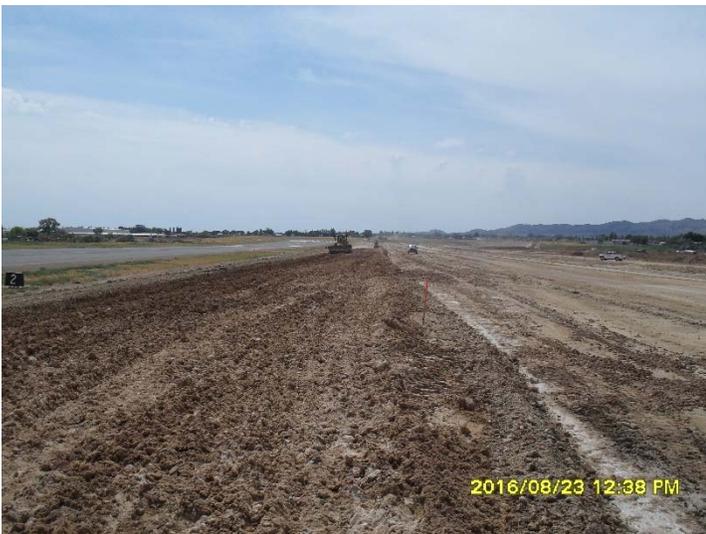
Placing embankment (8/23)

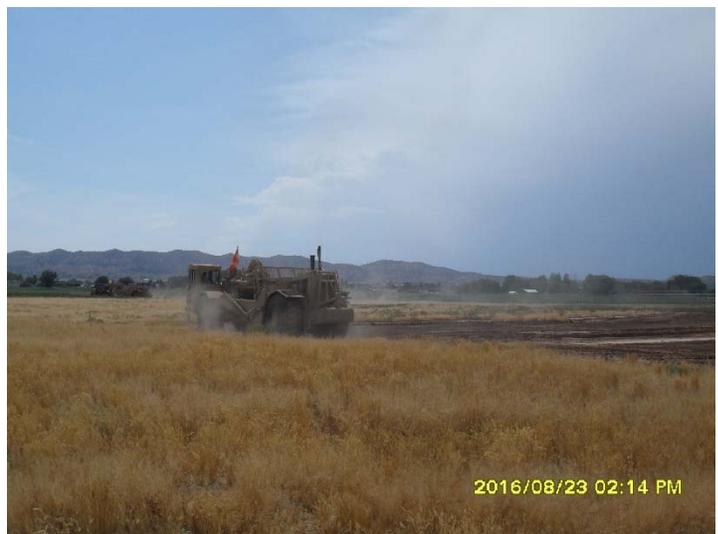
Scrapers stripping topsoil south of irrigation line (8/23)

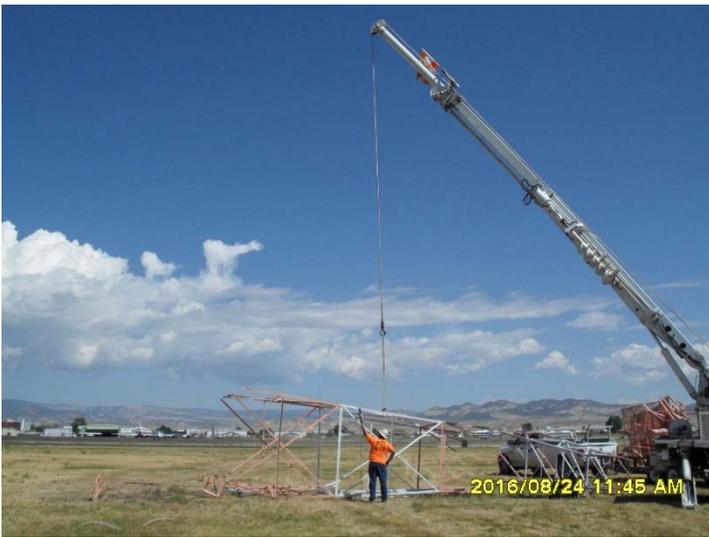
Demoing old beacon (8/24)

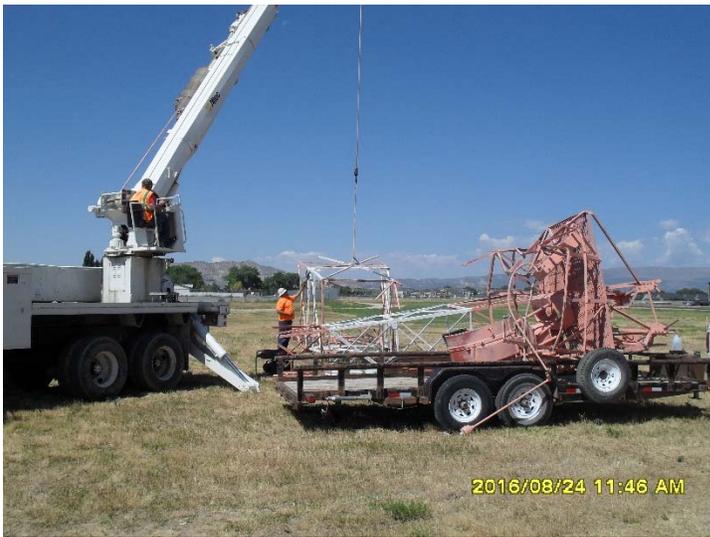
Demoing old beacon (8/24)

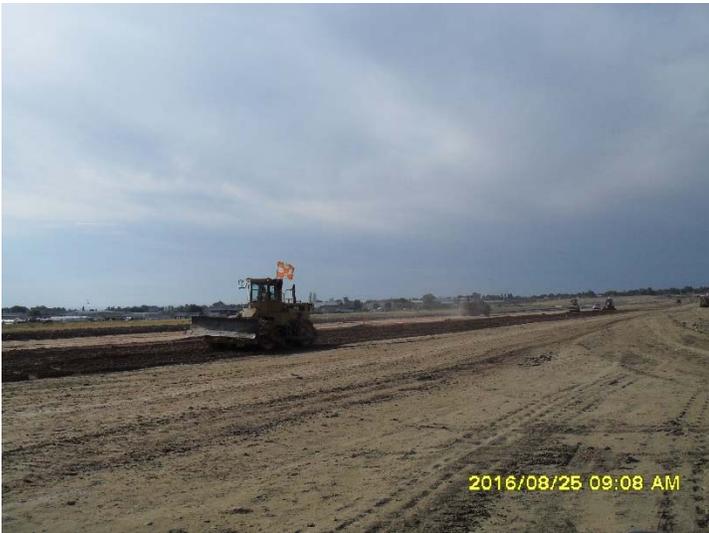
Placing embankment near proposed RWY CL (8/25)

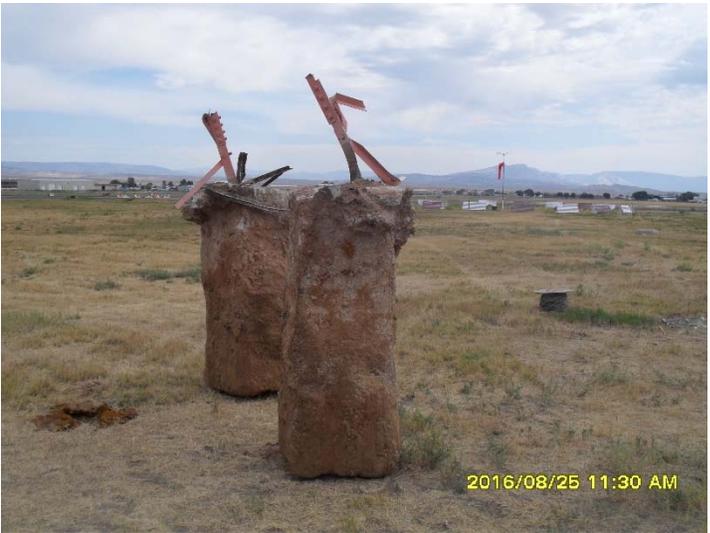
Demoing beacon foundation (8/25)

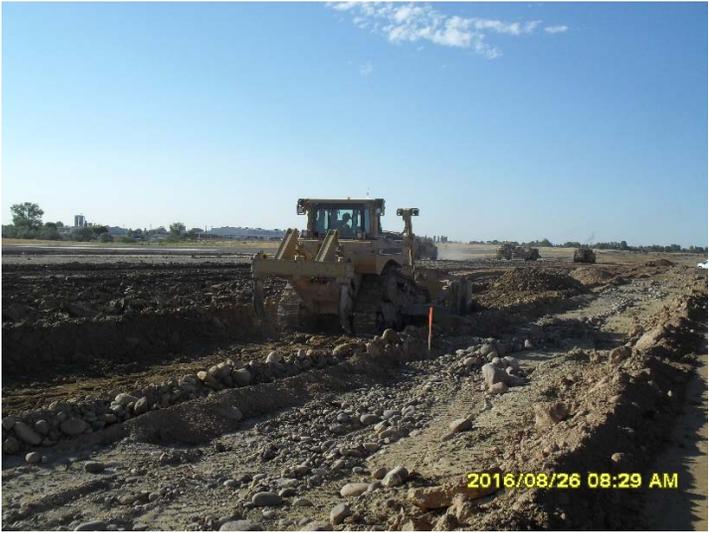
Scarifying soft spot (8/26)

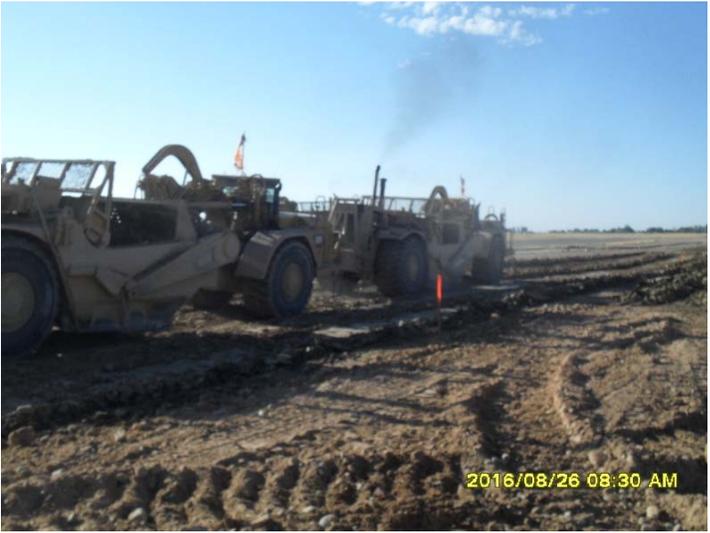
Scrapers removing material from soft spot (8/26)
