GDA Engineers
502 33rd Street
Cody, WY 82414

WEEKLY CONSTRUCTION PROGRESS AND INSPECTION REPORT

| September 2 nd , 2016 Weekly # 32 |
| 3-49-0037-032-2015 |

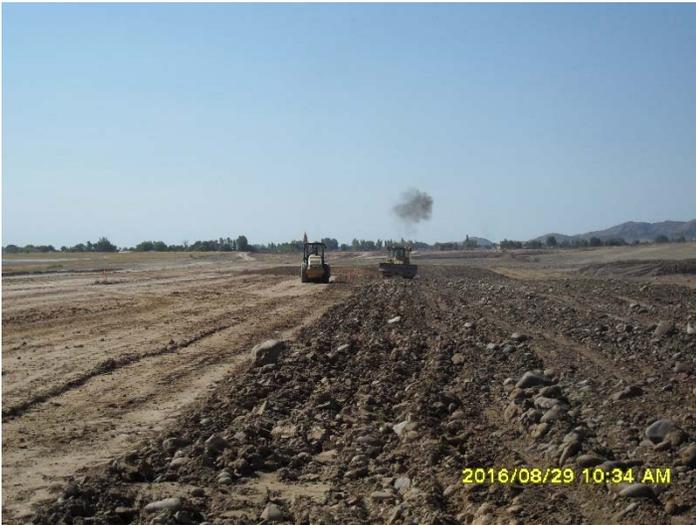
Placing embankment fill (8/29)

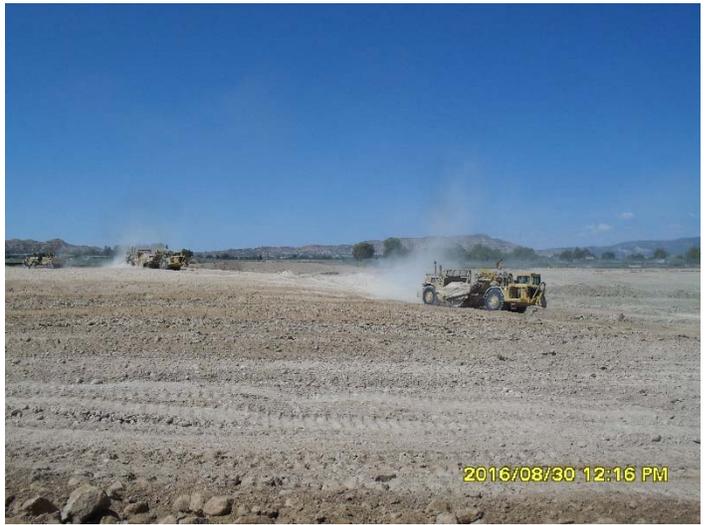
Taking fill from cut area (8/30)

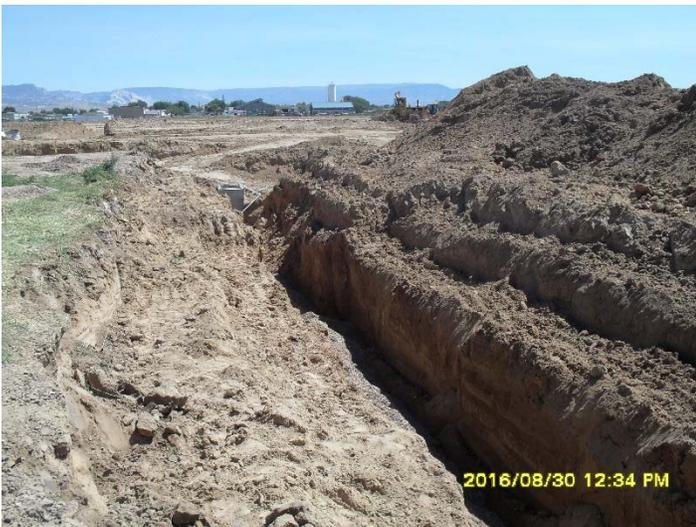
Installing southern ST-B lateral (8/30)

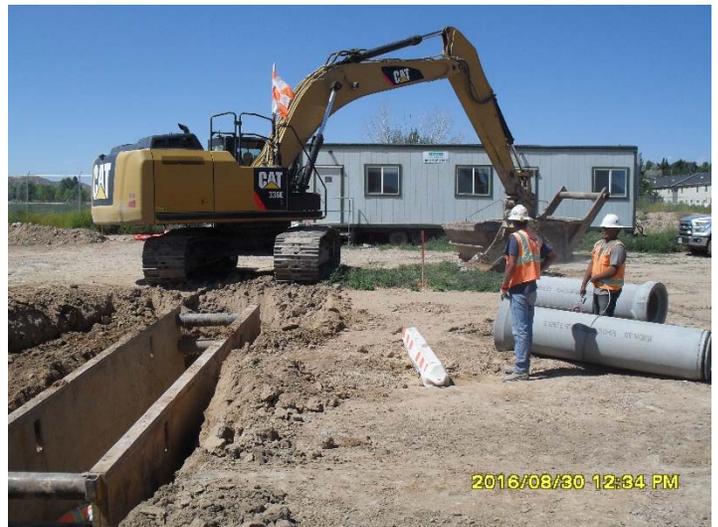
Installing southern ST-B lateral (8/30)

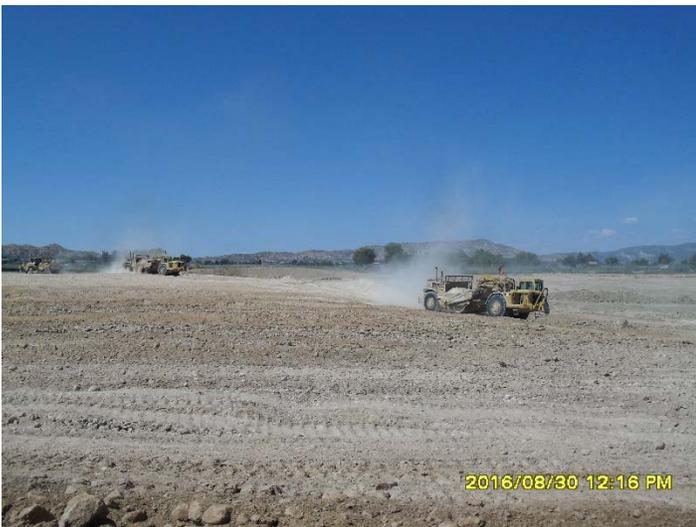
Scrapers hauling material from cut (8/30)

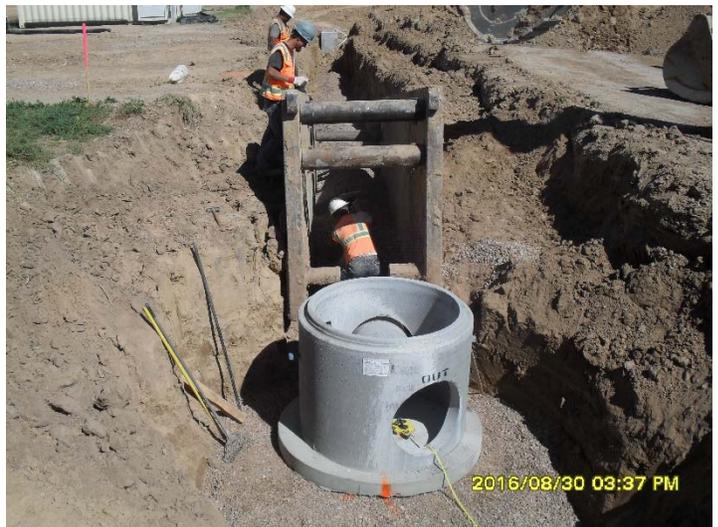
Installing MH ST-B6 (8/30)

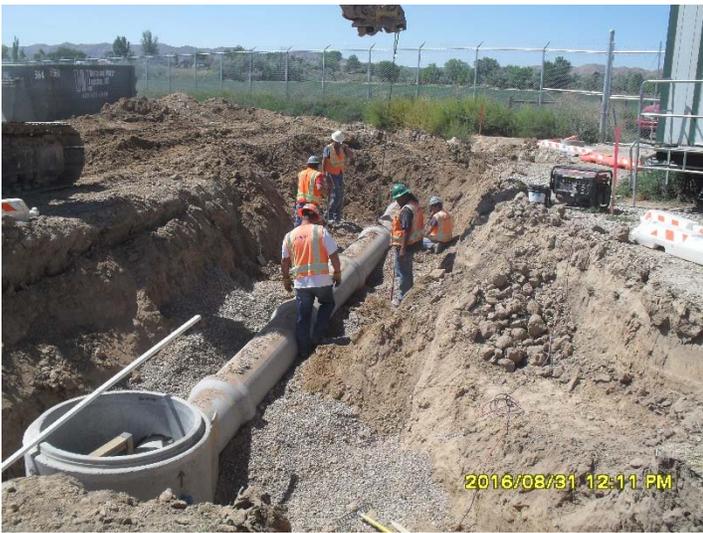
Installing southern ST-B lateral (9/1)

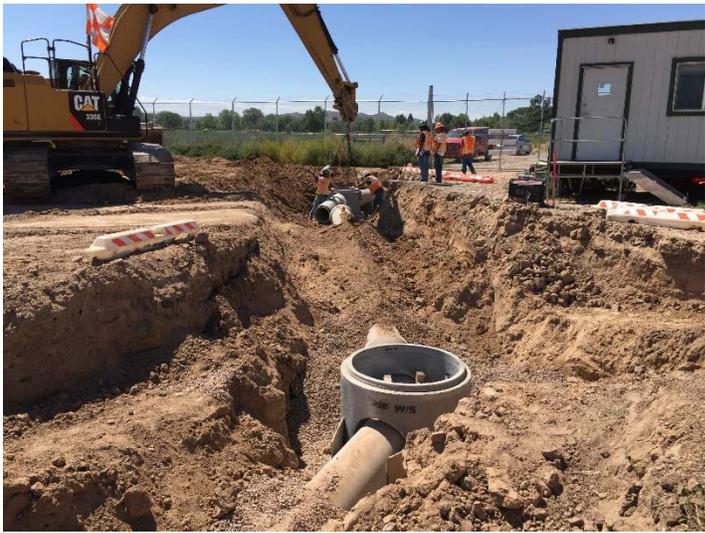
Installing southern ST-B lateral (9/1)

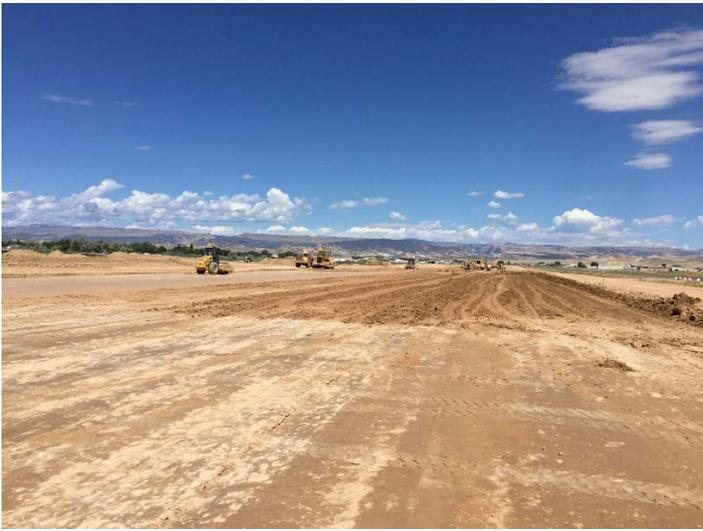
Working on 100% compaction area (9/2)

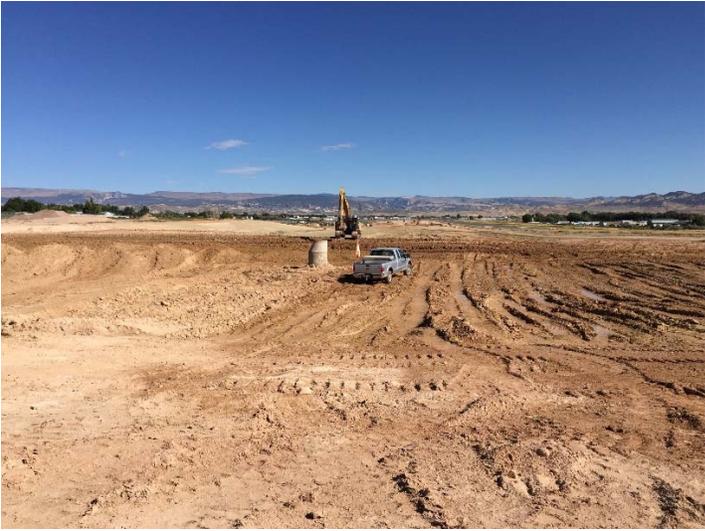
Cut area - MH will be removed (9/2)
