WEEKLY CONSTRUCTION PROGRESS AND INSPECTION REPORT

Period Ending
September 10 th , 2016 Weekly # 33
Project AIP Number
3-49-0037-032-2015

Airport Name Vernal Regional Airport (VEL)					
Project Description Earthwork and Drainage	Contractor's Name J. Wright Companies				
<p>1. Rough Estimate of Percent Completion to Date of Construction Phases <i>(Include items such as clearing, grading, drainage, base, surface, lighting, etc.)</i></p> <p>"Notice to Proceed" issued November 2, 2015</p> <p>Total Project Complete: 81%</p> <p>See attached Percent Complete spreadsheet.</p>					
<p>2. Work Completed or in Progress this Period.</p> <p>Earthwork crew completed first lift of 18" of 100% area under future pavement and worked on second lift from approx. STA 55+00 to 40+00. Pipe laying crew resumed laying 12" RCP from where they left on SD-D and completed pipe run on Wednesday. Concrete crew formed up and poured floor for SD-D/E headwall. Removed remaining existing underdrain from southmost inlet back upstation to next inlet (had been previously removed). On Saturday, earthwork crew worked on back catch slope on west slope from STA 40+00 to 45+00. Crew completed most of backfill on SD-D and

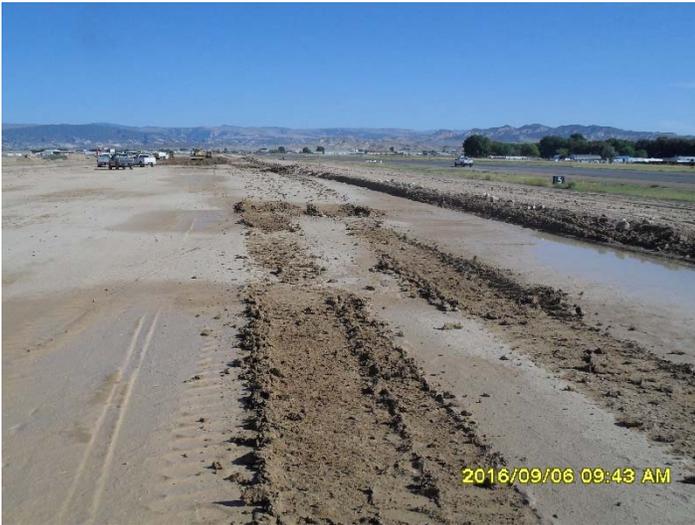
Wet conditions from weekend rains (9/6)

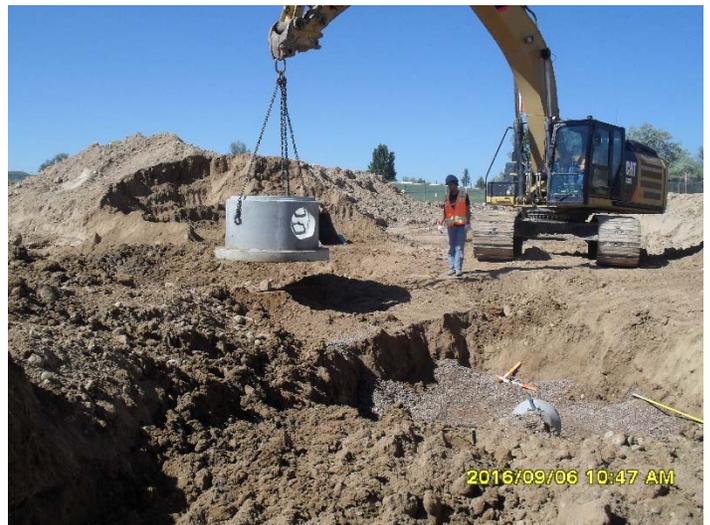
Setting MH SD-D1 (9/6)

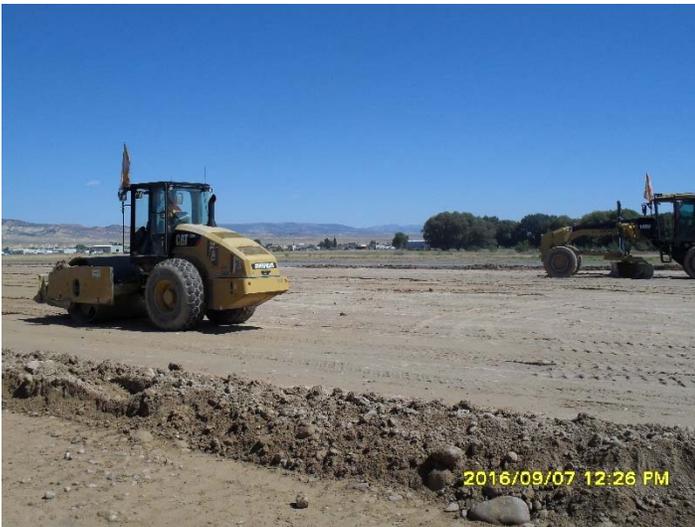
Compacting first lift of 100% layer (9/7)

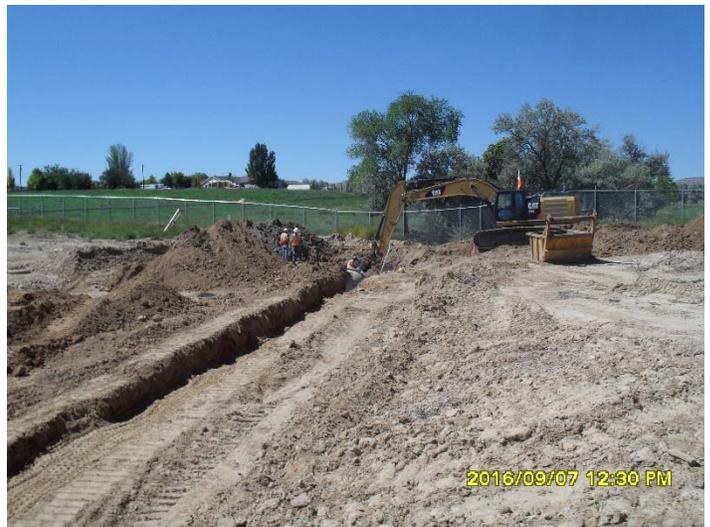
Installing SD-D (9/7)

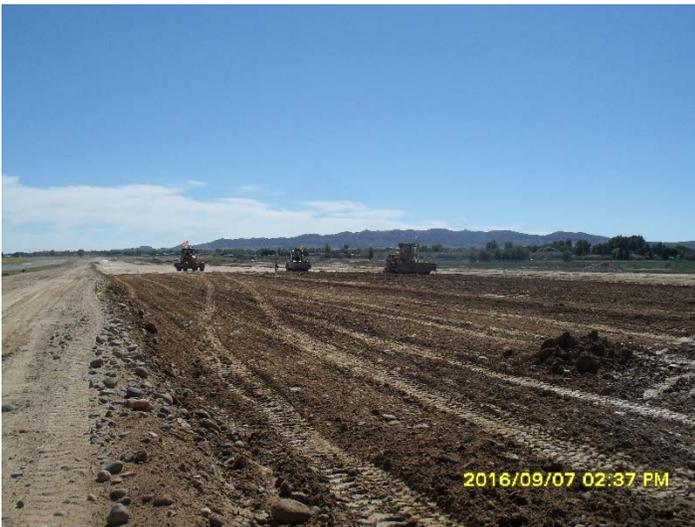
Placing first lift of 100% layer (9/7)

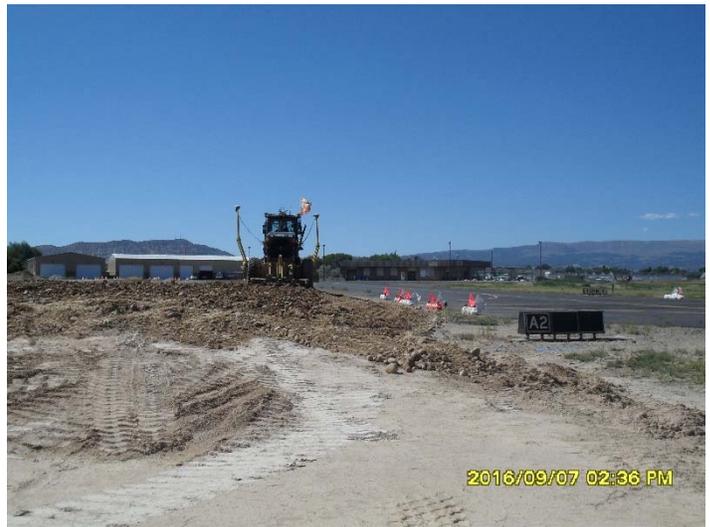
Grading near A2 (9/7)

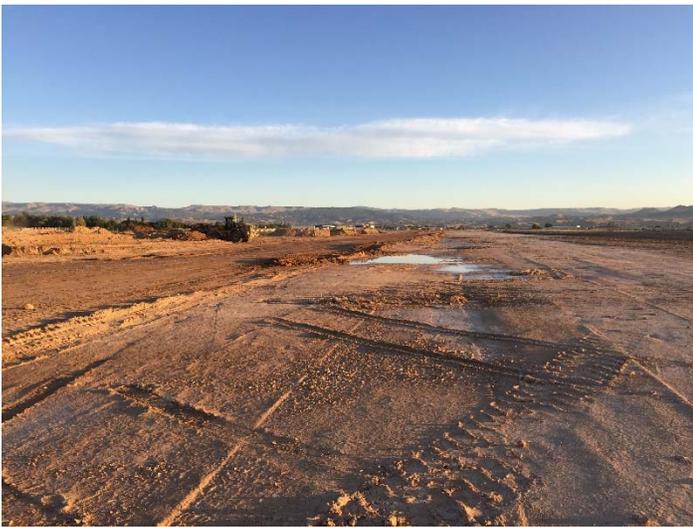
Wet conditions still occurring later in the week (9/8)

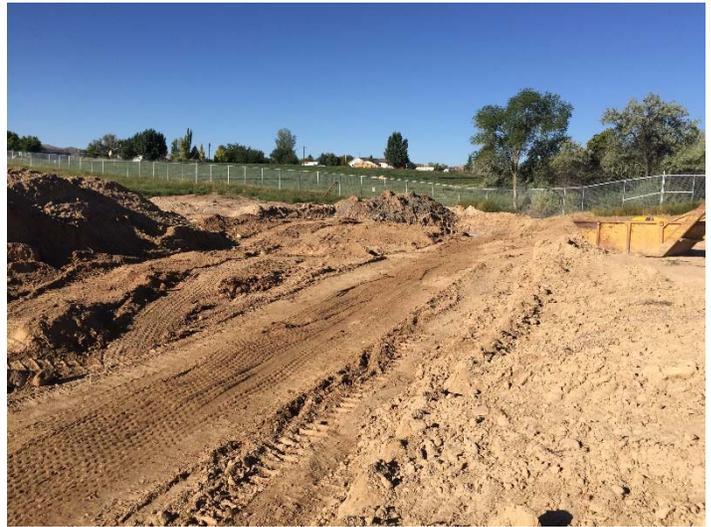
Backfill on SD-D (9/8)

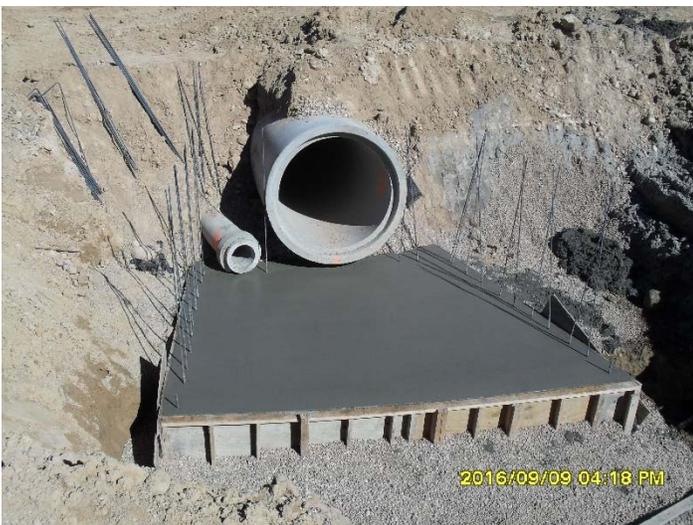
Poured floor for SD-D/E headwall (9/9)

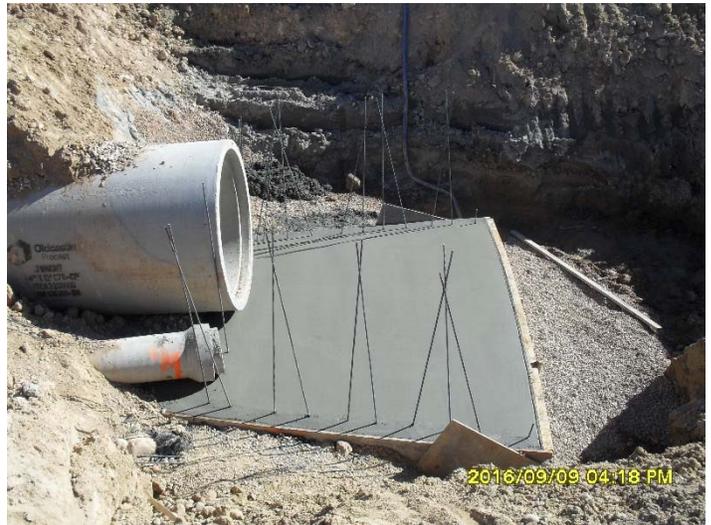
Poured floor for SD-D/E headwall (9/9)

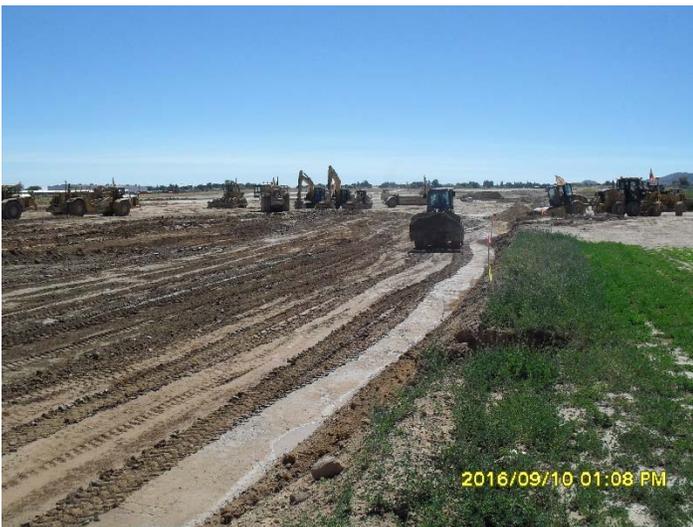
Shaping west slope (9/10)

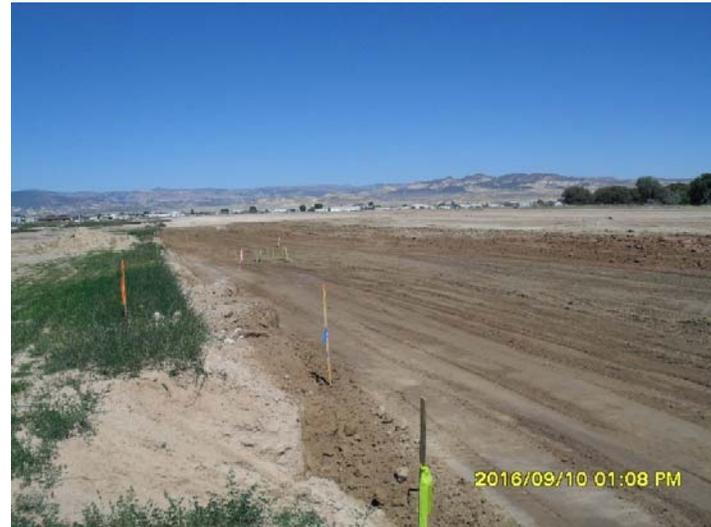
Shaping west slope (9/10)
