WEEKLY CONSTRUCTION PROGRESS AND INSPECTION REPORT

Period Ending
September 17 th , 2016 Weekly # 34
Project AIP Number
3-49-0037-032-2015

Airport Name Vernal Regional Airport (VEL)					
Project Description Earthwork and Drainage	Contractor's Name J. Wright Companies				
<p>1. Rough Estimate of Percent Completion to Date of Construction Phases <i>(Include items such as clearing, grading, drainage, base, surface, lighting, etc.)</i></p> <p>"Notice to Proceed" issued November 2, 2015</p> <p>Total Project Complete: 82%</p> <p>See attached Percent Complete spreadsheet.</p>					
<p>2. Work Completed or in Progress this Period.</p> <p>Earthwork crew placed embankment fill for the second lift in 100% zone up until the end of the day Monday. After the sheepsfoot roller broke down, the earthwork crew moved to placing fill on the toe and catch slope on the west slope and east slope. Pipe laying crew uncovered and checked grade of UD-A where pipe had been previously installed to the south of the commercial apron. Crew then resumed laying UD-A starting at MH UD-A3 to the north of the commercial apron and heading upstation. Heavy rains Tuesday night and Wednesday morning shut down earthwork cr

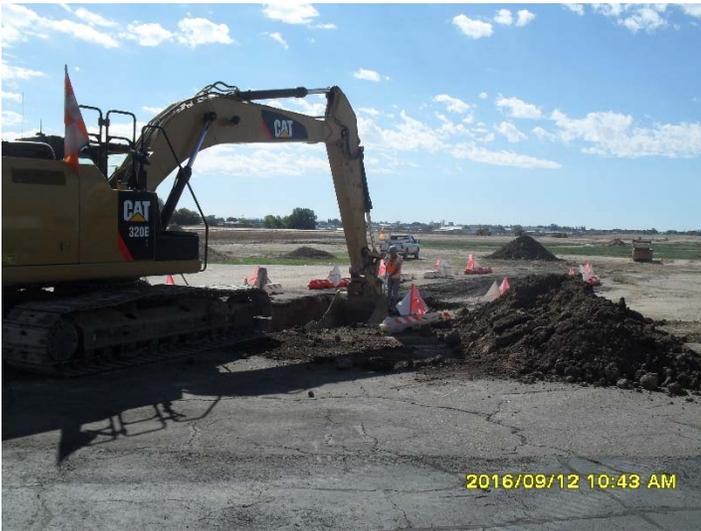
Checking grade on UD-A (9/12)

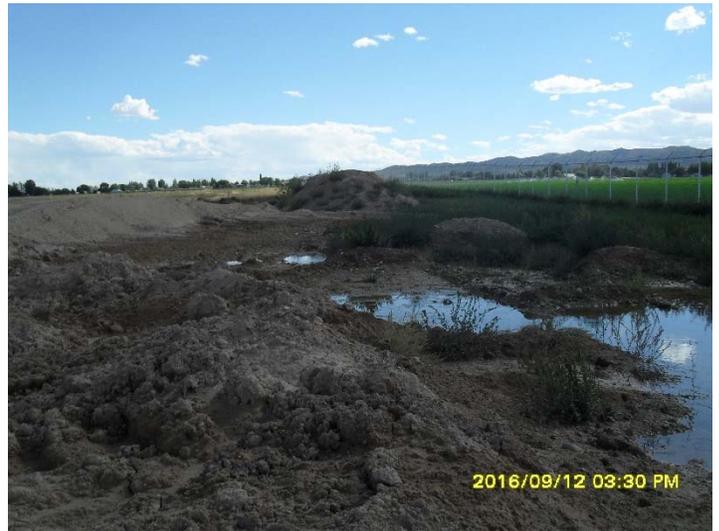
Irrigation water flooding cut area (9/12)

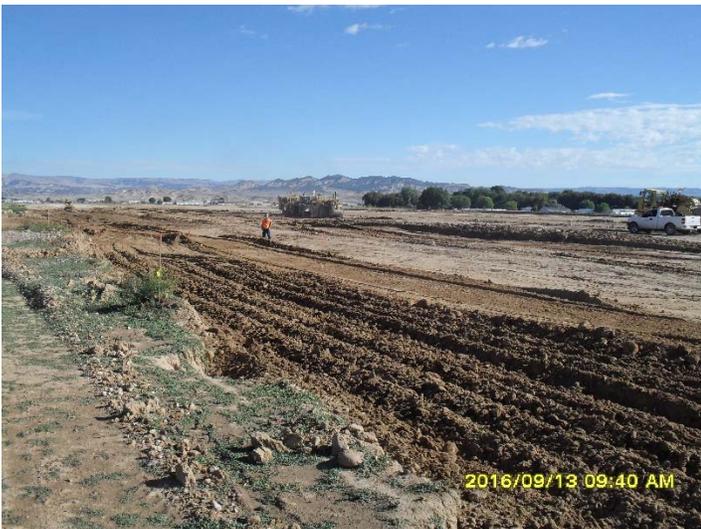
Filling and shaping embankment toe (9/13)

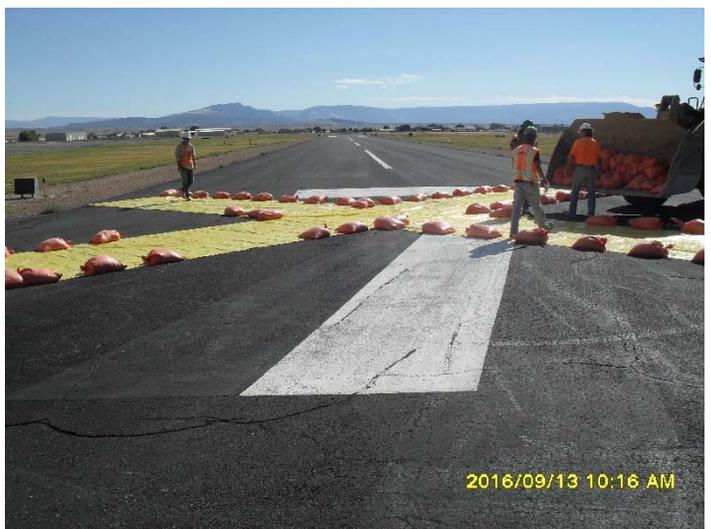
Placing closure X's on crosswind runway (9/13)

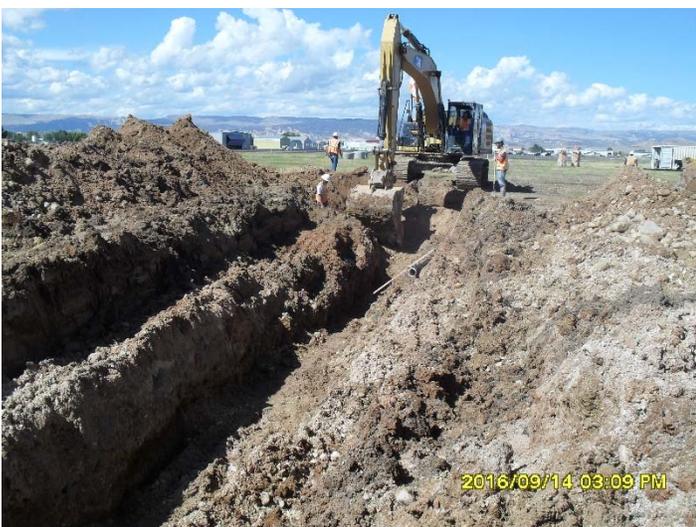
Installing UD-A (9/14)

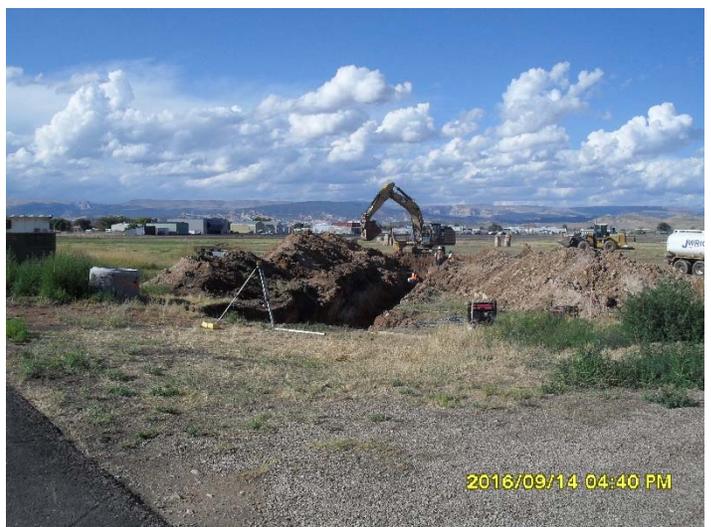
Installing UD-A (9/14)

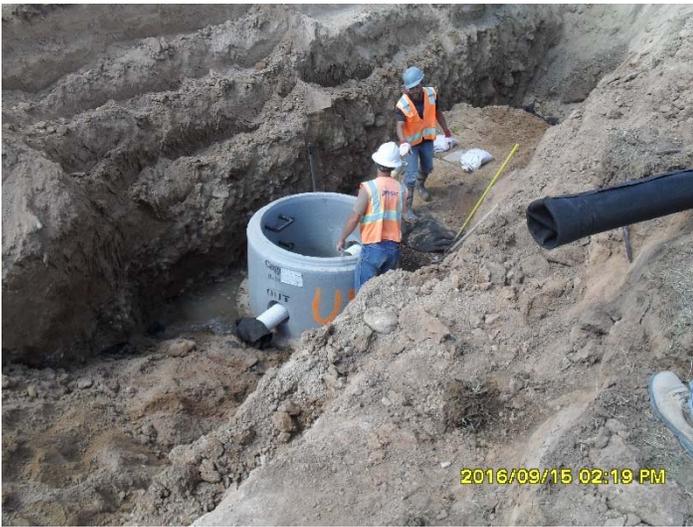
Installing MH UD-A2 (9/15)

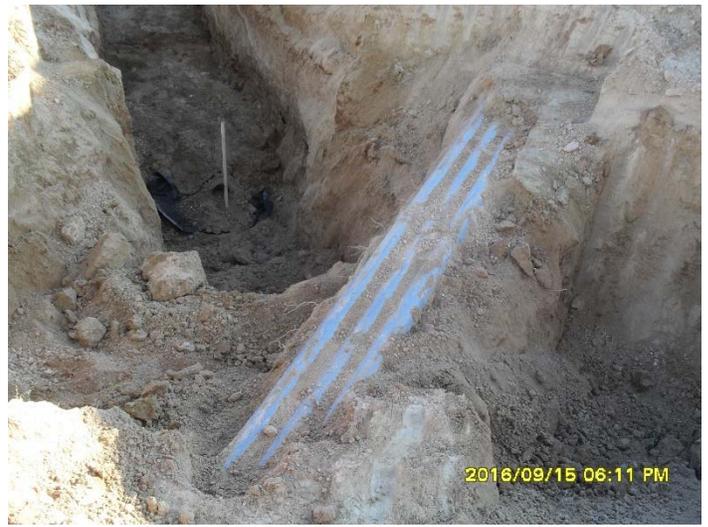
Crossing under powerline (9/15)

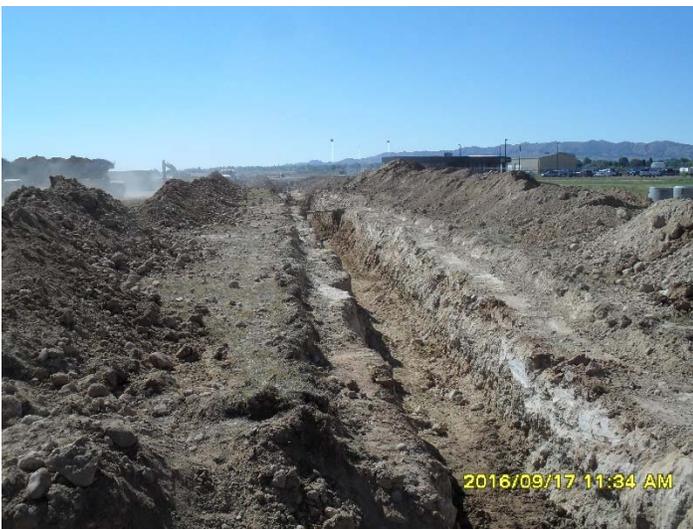
Installing UD-A (9/17)

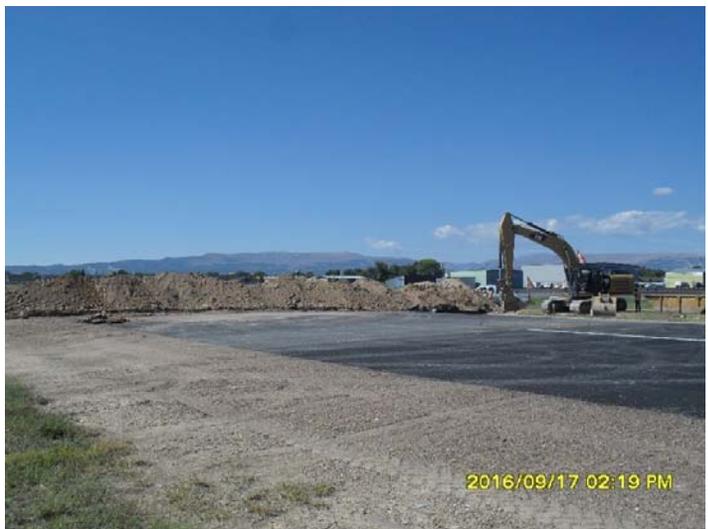
Installing UD-A across Runway 7-25 (9/17)

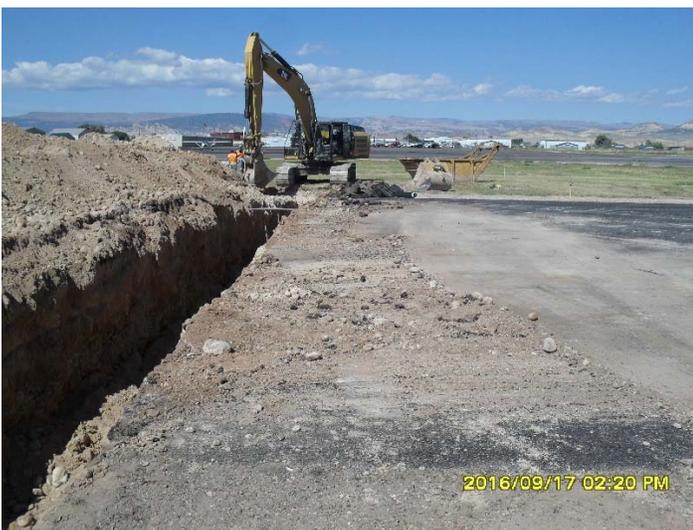
Installing UD-A across Runway 7-25 (9/17)

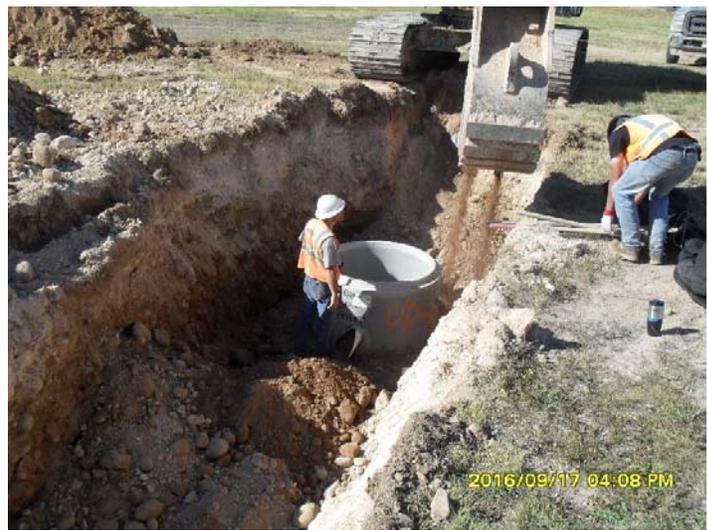
Installing MH UD-A1 (9/17)
