WEEKLY CONSTRUCTION PROGRESS AND INSPECTION REPORT

Period Ending September 24 th , 2016 Weekly # 35
Project AIP Number 3-49-0037-032-2015

Airport Name Vernal Regional Airport (VEL)					
Project Description Earthwork and Drainage	Contractor's Name J. Wright Companies				
<p>1. Rough Estimate of Percent Completion to Date of Construction Phases <i>(Include items such as clearing, grading, drainage, base, surface, lighting, etc.)</i></p> <p>"Notice to Proceed" issued November 2, 2015</p> <p>Total Project Complete: 83%</p> <p>See attached Percent Complete spreadsheet.</p>					
<p>2. Work Completed or in Progress this Period.</p> <p>Crew installed remainder of UD-A (from 10+71 to 0+00) by midday Tuesday. Crew then focused their efforts to backfill UD-A, specifically the areas under Runway 7-25 and the commercial apron. Night shift occurred on Tuesday and Wednesday night to work on backfilling UD-A (a working day is charged for day shift and a working day is charged for night shift). Heavy rains Thursday and Friday prevented work from occurring. Crew spent Saturday and Sunday removing material from under the runway and apron pavements to clean up saturated material and replace with dry

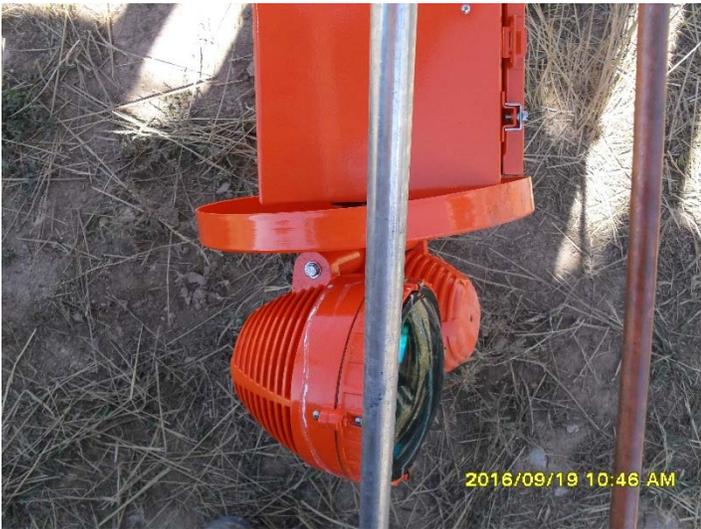
Bent weather plate from counterweight cable failing (9/19)

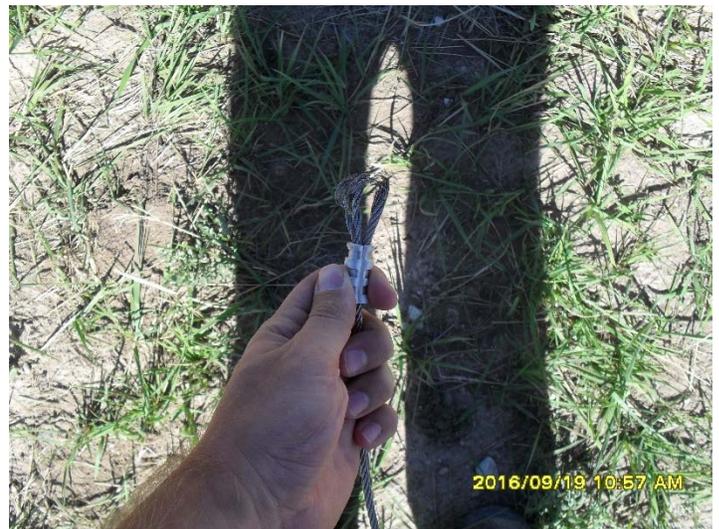
Failed counterweight cable on beacon (9/19)

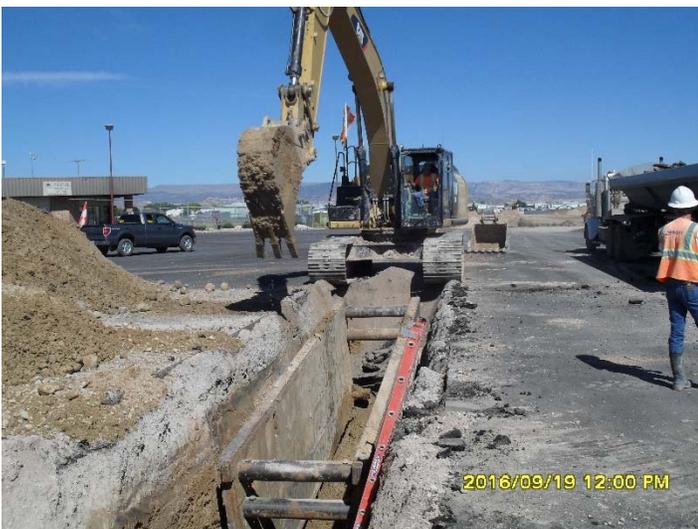
Installing UD-A through commercial apron (9/20)

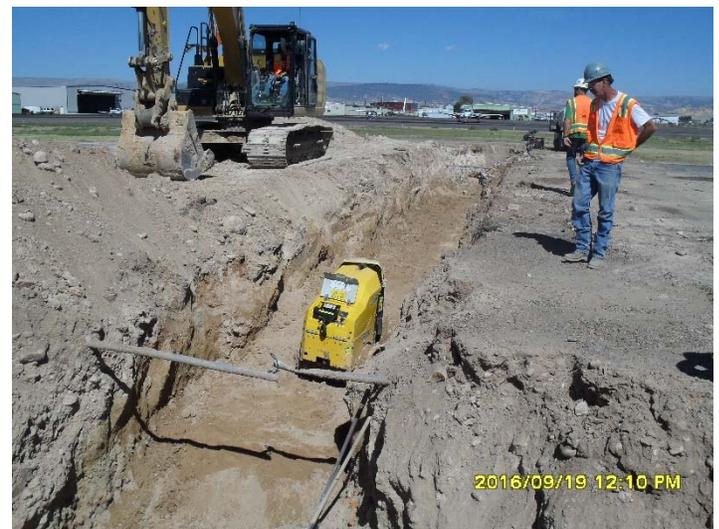
Backfilling UD-A under Runway 7-25 (9/20)

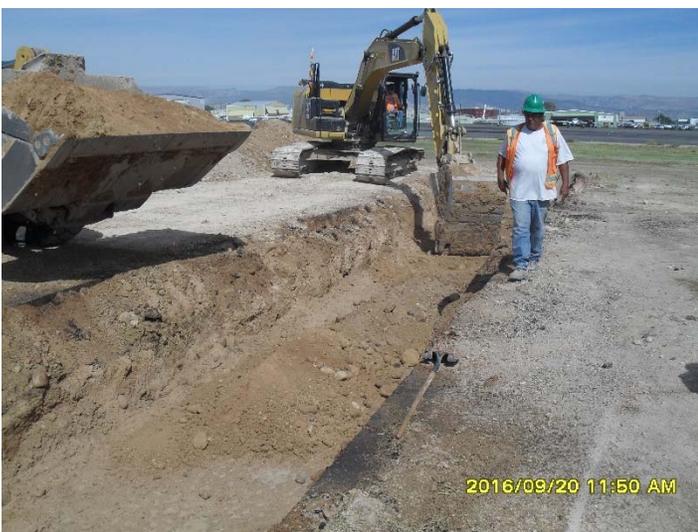
Backfilling UD-A under Runway 7-25 (9/20)

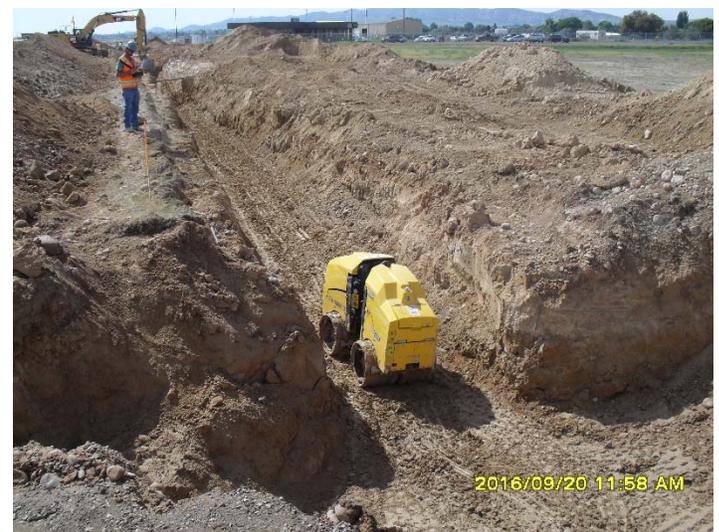
Backfilling UD-A (9/20)

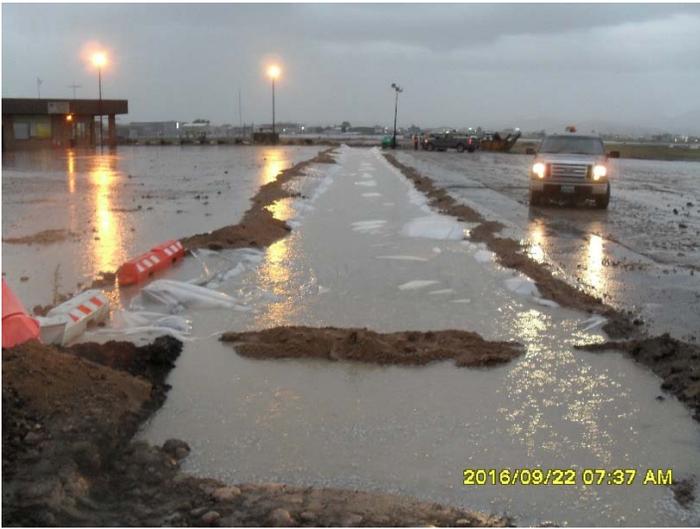
Heavy rains on Thursday (9/22)

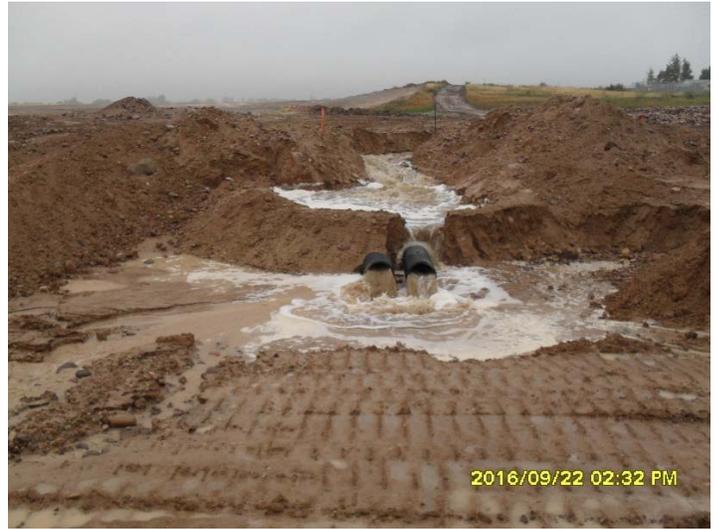
Heavy rains washing out culvert (9/22)

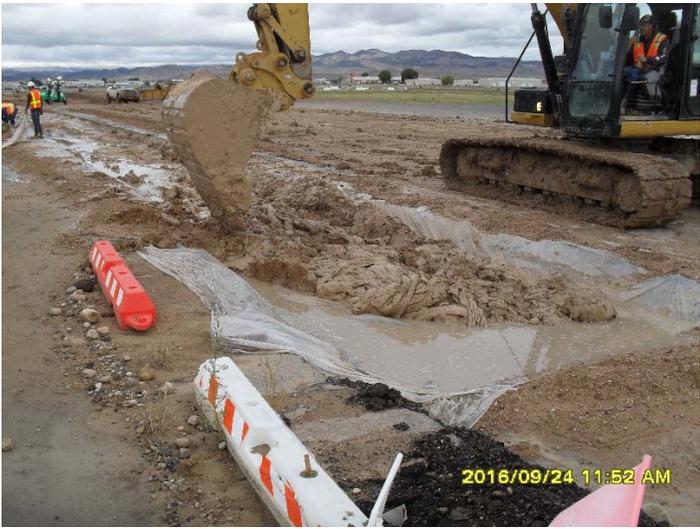
Removing saturated P-208 (9/24)

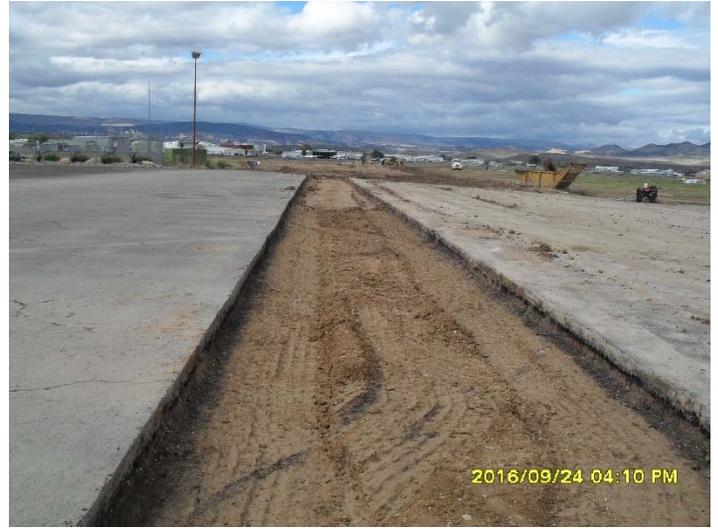
Working on P-208 (9/24)
