## WEEKLY CONSTRUCTION PROGRESS AND INSPECTION REPORT

Period Ending September 30 <sup>th</sup> , 2016 Weekly # 36
Project AIP Number  3-49-0037-032-2015

Airport Name Vernal Regional Airport (VEL)					
Project Description Earthwork and Drainage	Contractor's Name J. Wright Companies				
<p>1. Rough Estimate of Percent Completion to Date of Construction Phases (<i>Include items such as clearing, grading, drainage, base, surface, lighting, etc.</i>)</p> <p>"Notice to Proceed" issued November 2, 2015</p> <p>Total Project Complete: 84%</p> <p>See attached Percent Complete spreadsheet.</p>					
<p>2. Work Completed or in Progress this Period.</p> <p>Crew paved asphalt patch for Runway 7-25 and commercial apron. Crew spent Tuesday cleaning up areas around Runway 7-25 and commercial apron (grading, minor backfilling around MHs, and sweeping of pavement) so that NOTAMs could be lifted Wednesday morning. Crew excavated slopes and placed grouted riprap for SD-E/D. A small earthwork crew spent Wednesday scarifying and recompacting shoulders on west slope to remove excess water from rains last week. Rains on Thursday created saturated conditions and no working day was charged for Thursday and

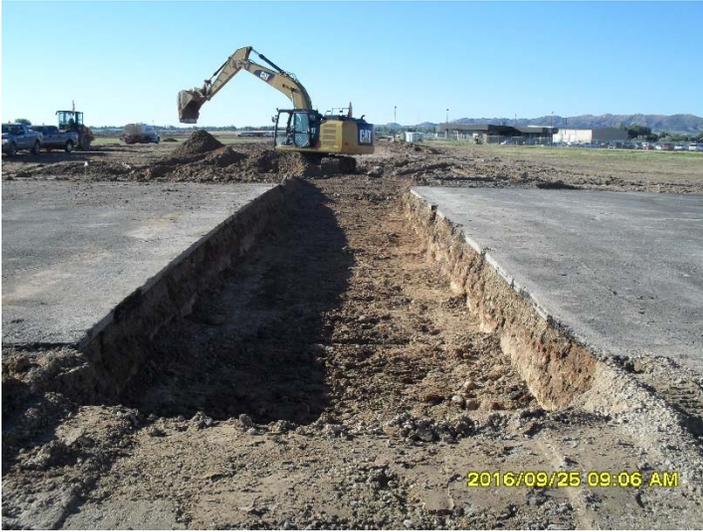
Placing dry material under Runway 7-25 (9/25)

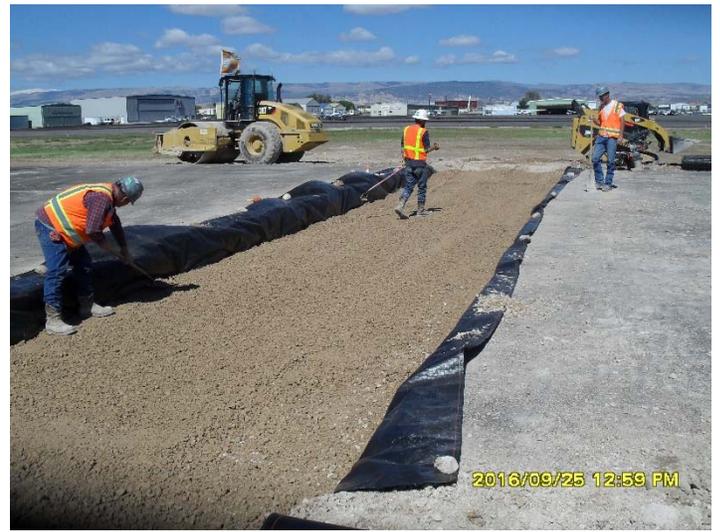
Placing P-208 (9/25)

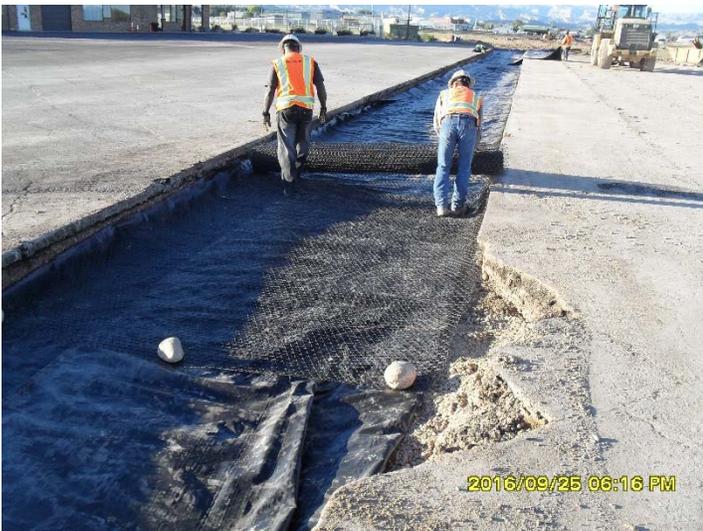
Placing geogrid under P-208 (9/25)

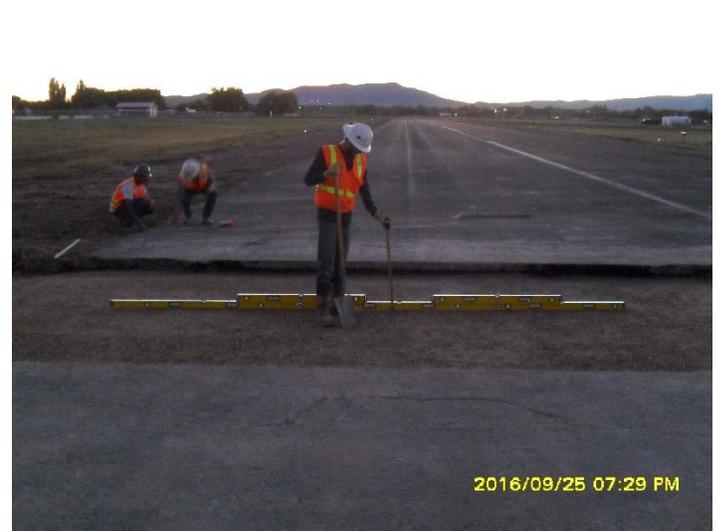
Checking P-208 smoothness (9/25)

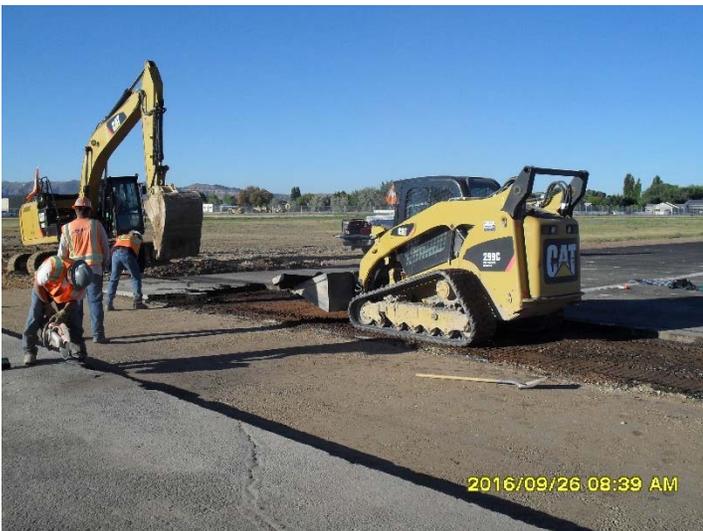
Preparing for paving (9/26)

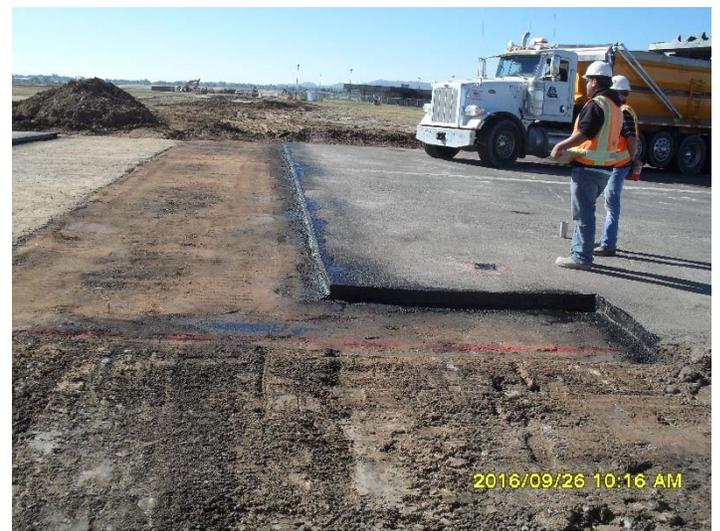
Tacking edges prior to paving (9/26)

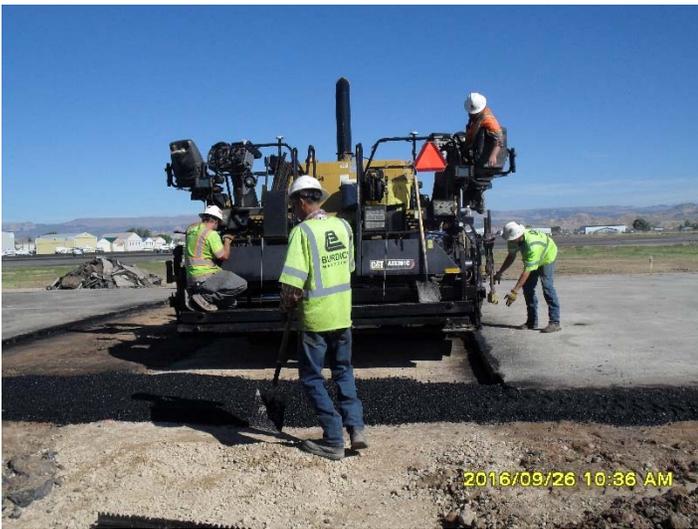
Paving runway patch (9/26)

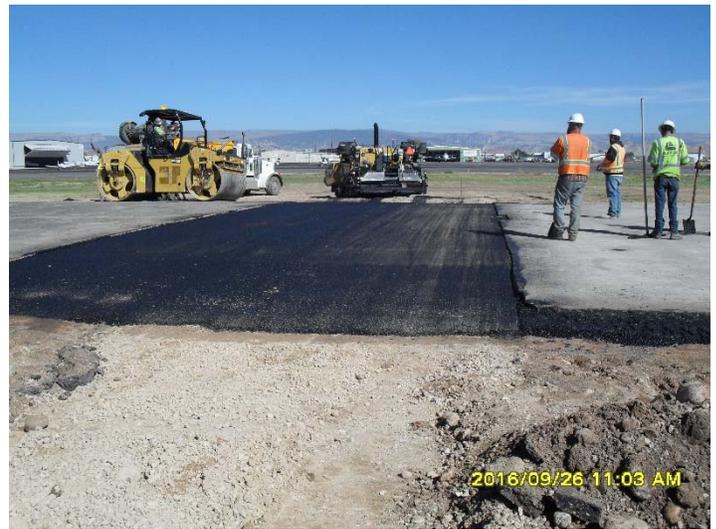
Paving runway patch (9/26)

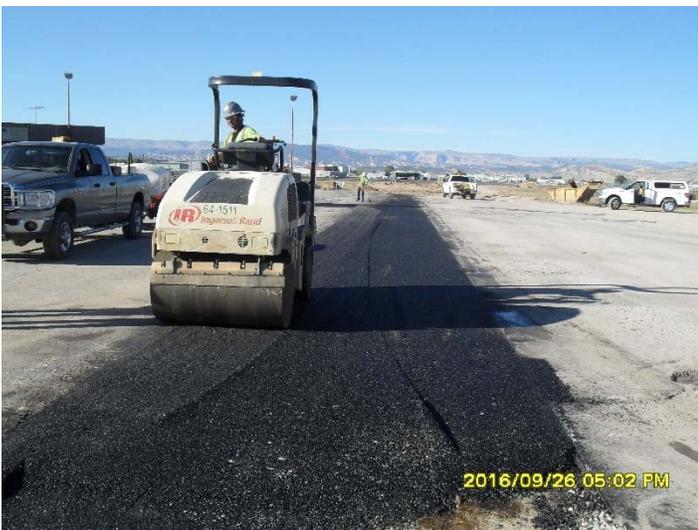
Paving apron patch (9/26)

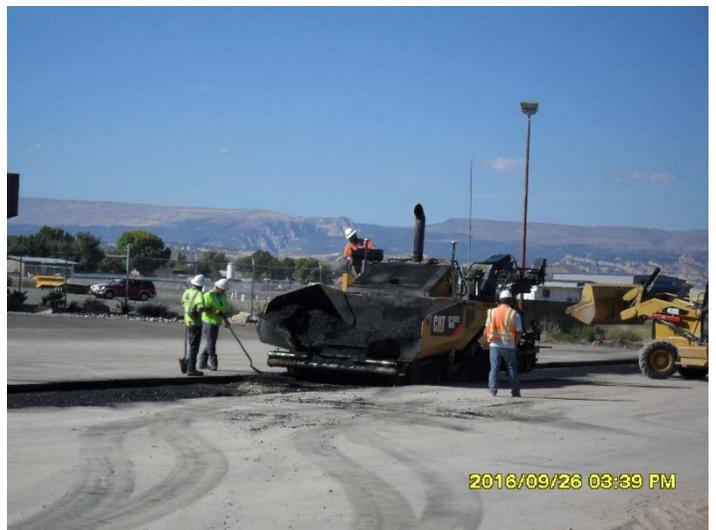
Paving apron patch (9/26)

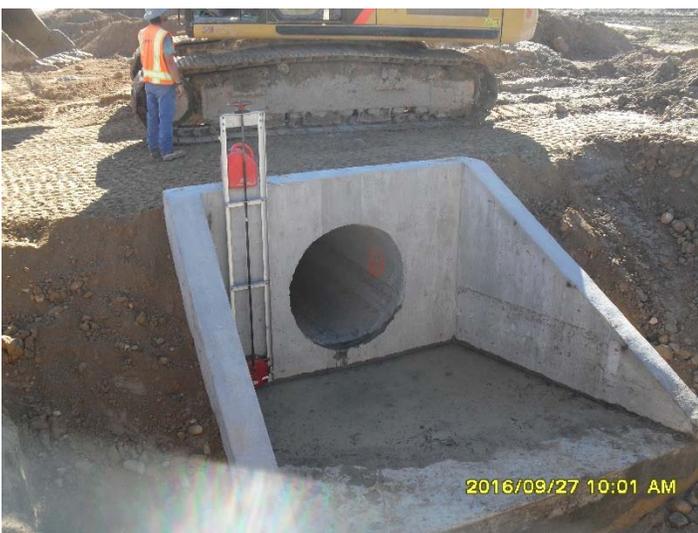
SD-E/D headwall w/ gate (9/27)

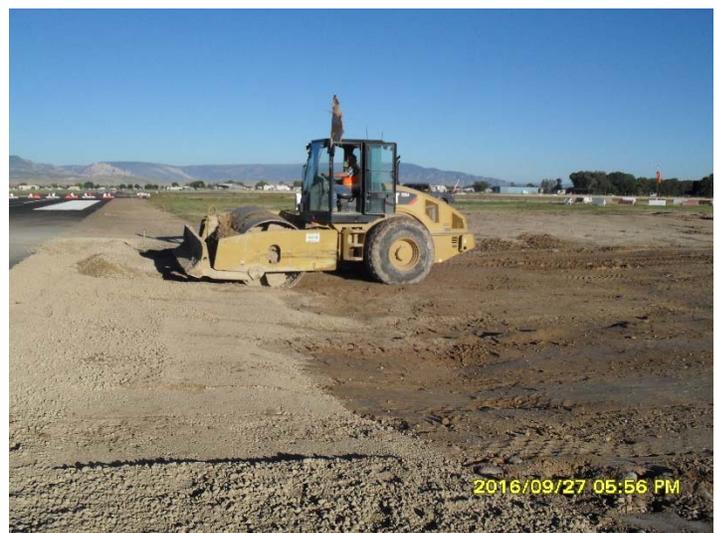
Cleaning up around Runway 7-25 (9/27)

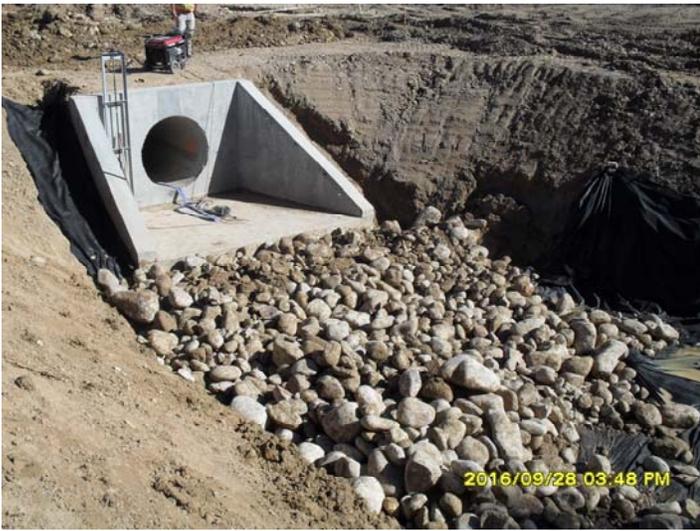
Placing riprap for SD-E/D (9/28)

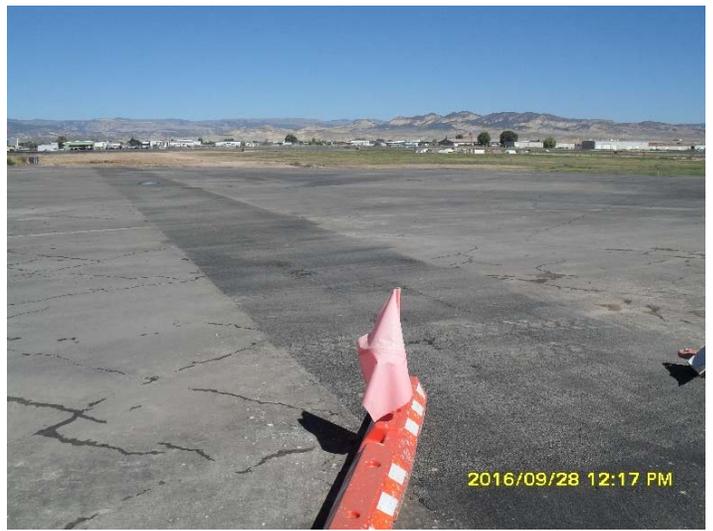
Overview of apron patch (9/28)
