## WEEKLY CONSTRUCTION PROGRESS AND INSPECTION REPORT

Period Ending November 5 <sup>th</sup> , 2016 Weekly # 41
Project AIP Number  3-49-0037-032-2015

Airport Name Vernal Regional Airport (VEL)					
Project Description Earthwork and Drainage	Contractor's Name J. Wright Companies				
<p>1. Rough Estimate of Percent Completion to Date of Construction Phases <i>(Include items such as clearing, grading, drainage, base, surface, lighting, etc.)</i></p> <p>"Notice to Proceed" issued November 2, 2015</p> <p>Total Project Complete: 93%</p> <p>See attached Percent Complete spreadsheet.</p>					
<p>2. Work Completed or in Progress this Period.</p> <p>Due to rains on Monday morning, crew spent Monday filling in low spots on west slope and obtaining remaining passing QA/QC tests along the shoulder from 13+00 to 55+00. On Tuesday, crew moved back to runway surface and worked on final grading surface from approximately STA 24+00 and completing grading to approximately STA 38+00 by the end of the week. BHI installed primary windcone and removed existing windcone, segmented circle, and conduit/wire feeding existing windcone. Dozer and scrapers removed remainder of cut material in SW corner of cu

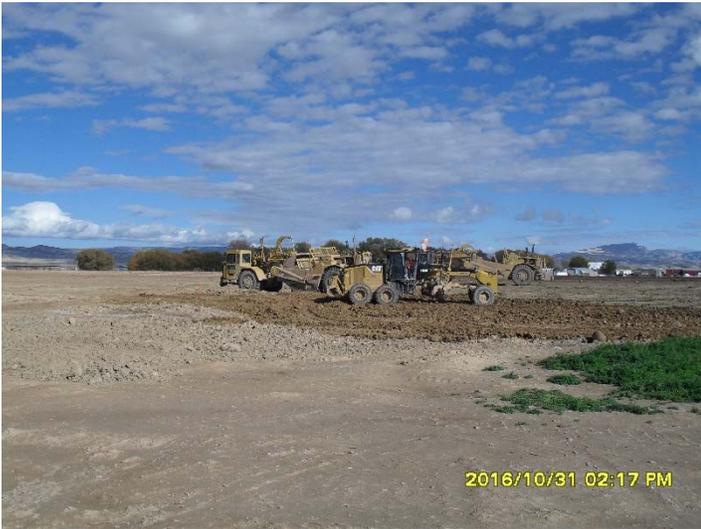
Placing material on west slope (10/31)

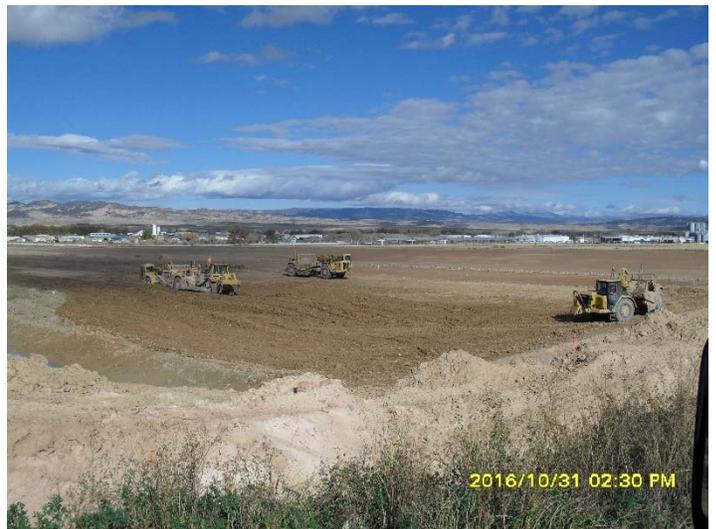
Removing material from cut (10/31)

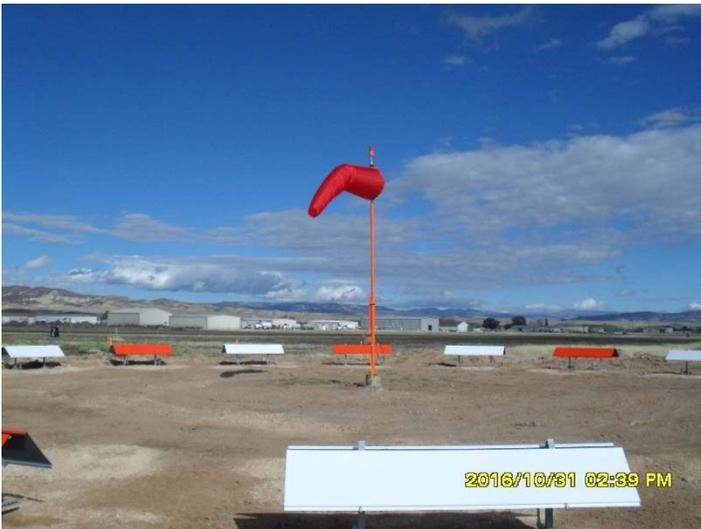
Installed primary windcone (10/31)

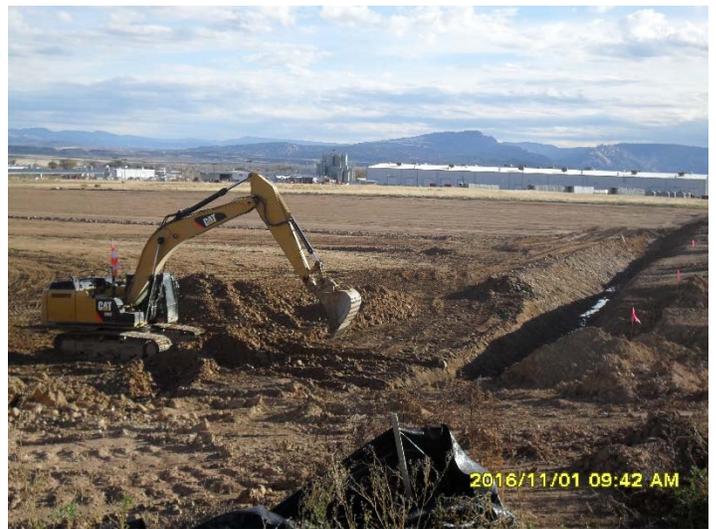
Cleaning up cut area (11/1)

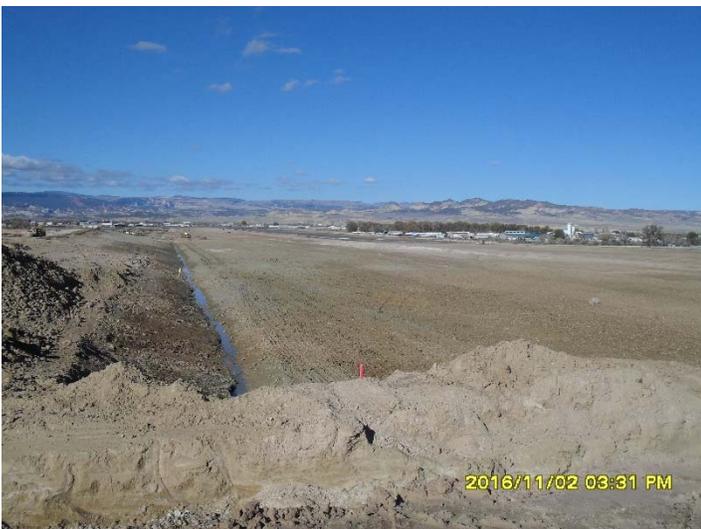
Cut area cut to grade (11/2)

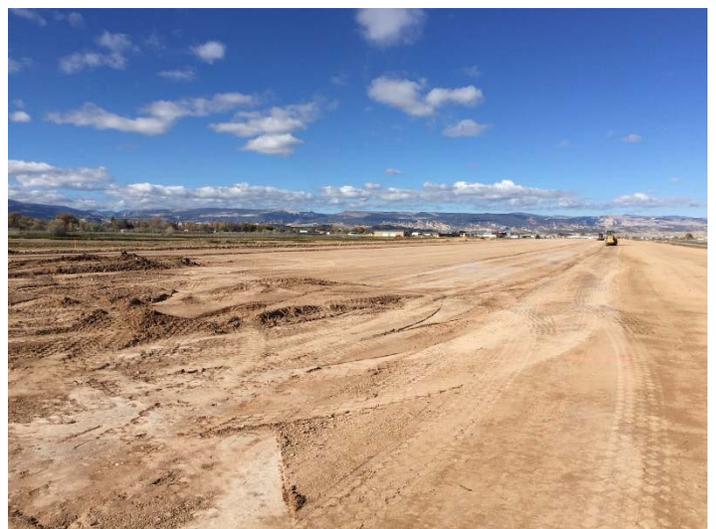
Grading runway surface (11/2)

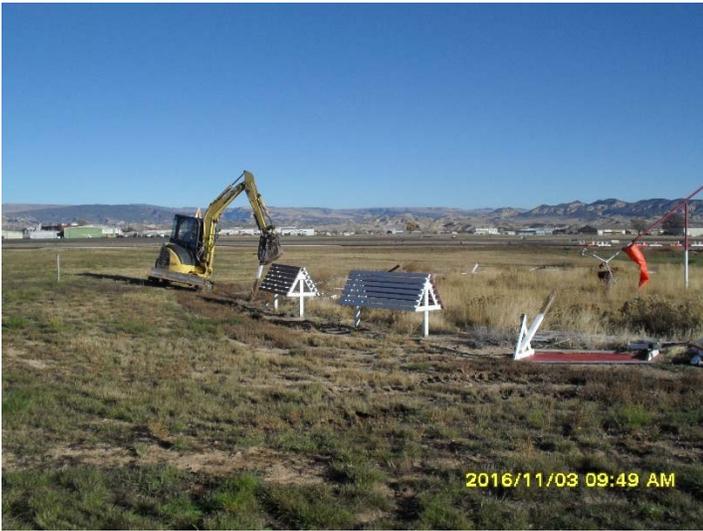
Demoing existing segmented circle (11/3)

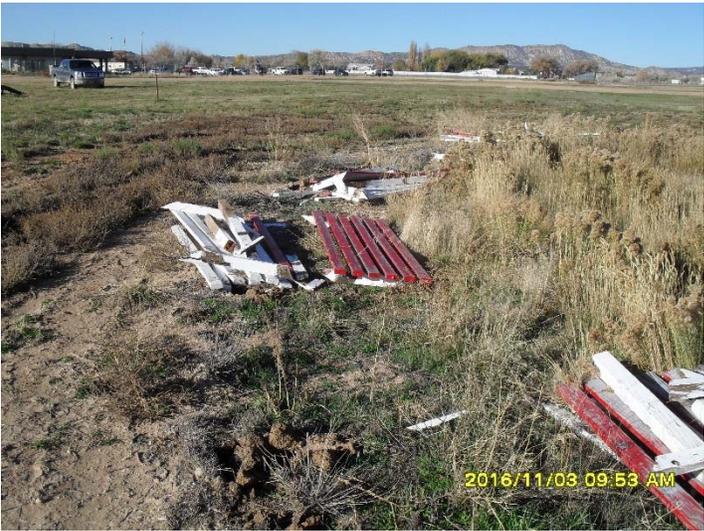
Demoing segmented circle (11/3)

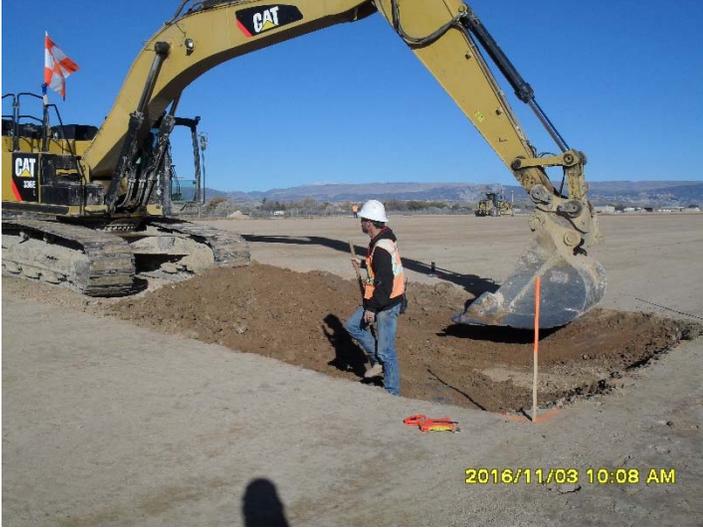
Grading for riprap ditch (11/3)

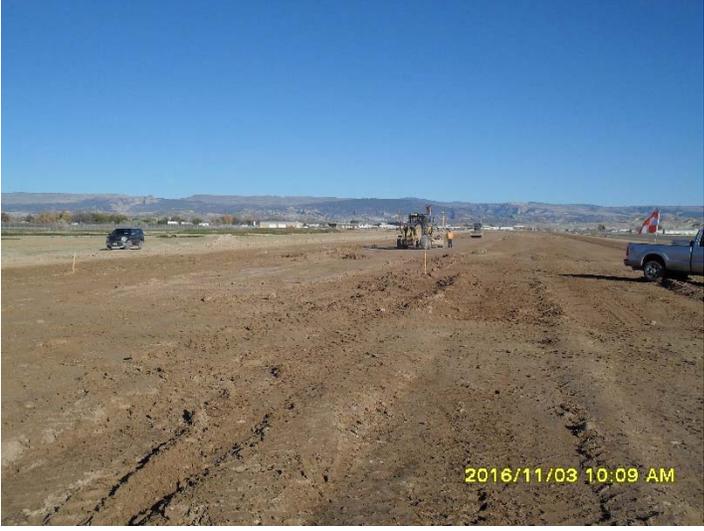
Grading runway surface (11/3)

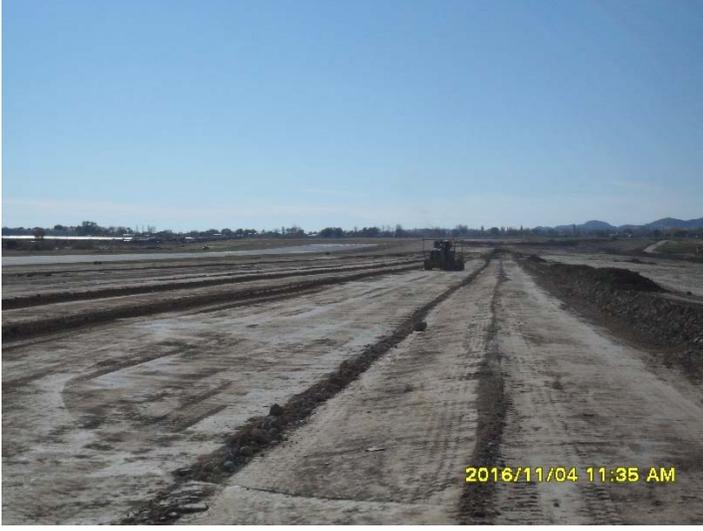
Grading runway surface (11/4)

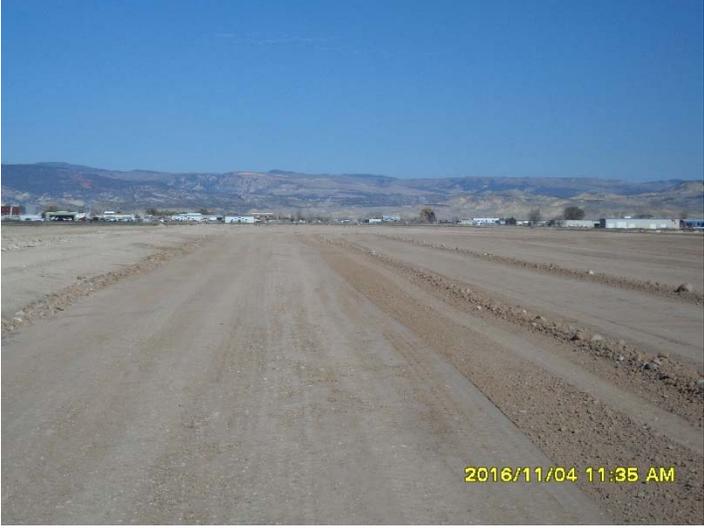
Grading runway surface (11/4)

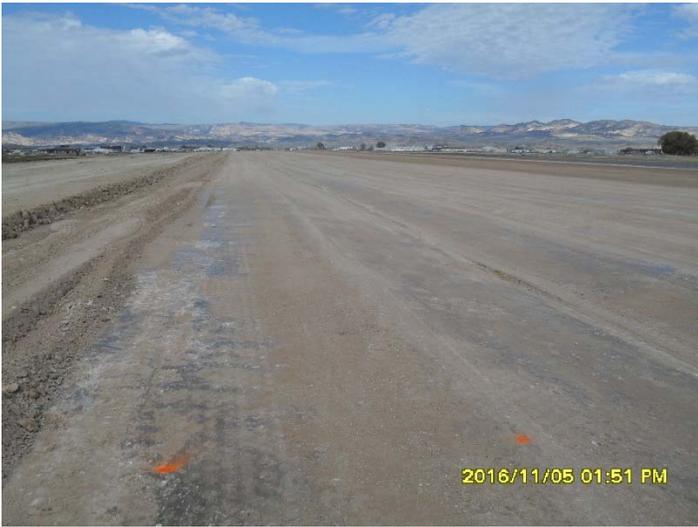
Grading runway surface (11/5)

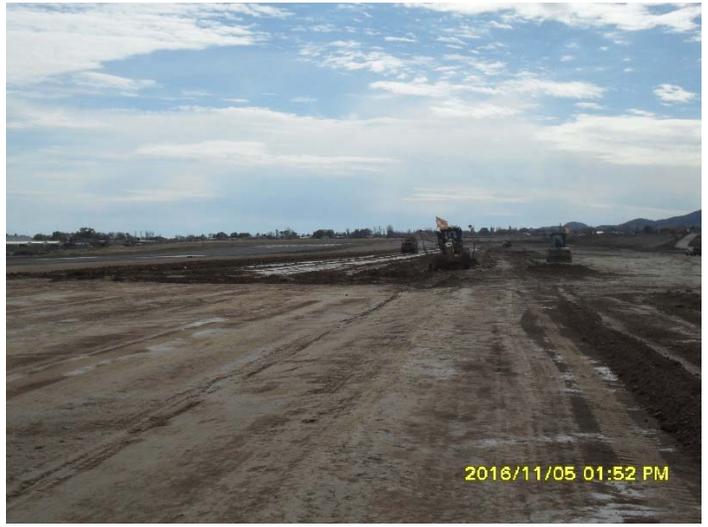
Grading runway surface (11/5)
