## WEEKLY CONSTRUCTION PROGRESS AND INSPECTION REPORT

Period Ending
May 27 <sup>th</sup> , 2016 Weekly # 20
Project AIP Number
3-49-0037-032-2015

Airport Name Vernal Regional Airport (VEL)					
Project Description Earthwork and Drainage	Contractor's Name J. Wright Companies				
1. Rough Estimate of Percent Completion to Date of Construction Phases <i>(Include items such as clearing, grading, drainage, base, surface, lighting, etc.)</i>  "Notice to Proceed" issued November 2, 2015  Total Project Complete: 40%  See attached Percent Complete spreadsheet.					
2. Work Completed or in Progress this Period.  Completed placement of SD-B and SD-C pipe, and continued to backfill on these pipe runs. Subcontractor began laying UD-A pipe starting at MH #UD-A10 and moving upstation. Set MH #UD-A9 and UD-A8. Tied in UD-A to previously installed MH #UD-A7. Continued laying 54" RCP for SD-E. Set first MH on SD-A and began laying pipe upstation. Continued building up embankment from STA 25+00 to 40+00. Poured SD-B and SD-C headwalls and placed rip rap for SD-C and SD-B and turned water down SD-C to help prevent flooding. Placed electrical conduit across connector A5.					
3. Brief Weather Summary

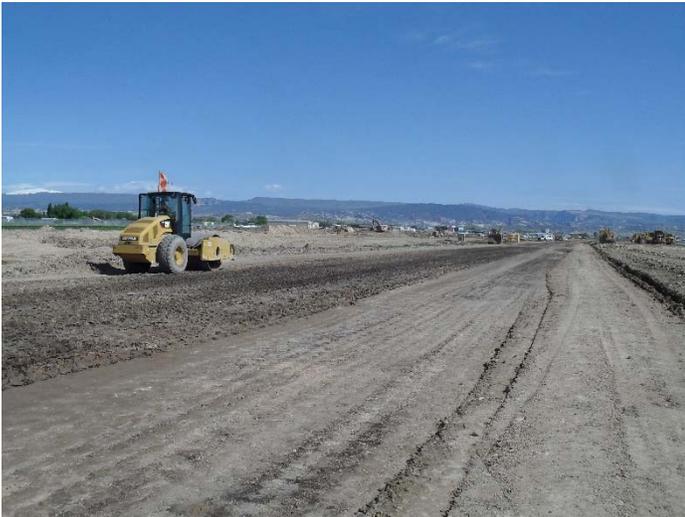
Placing and compacting embankment (5/24)

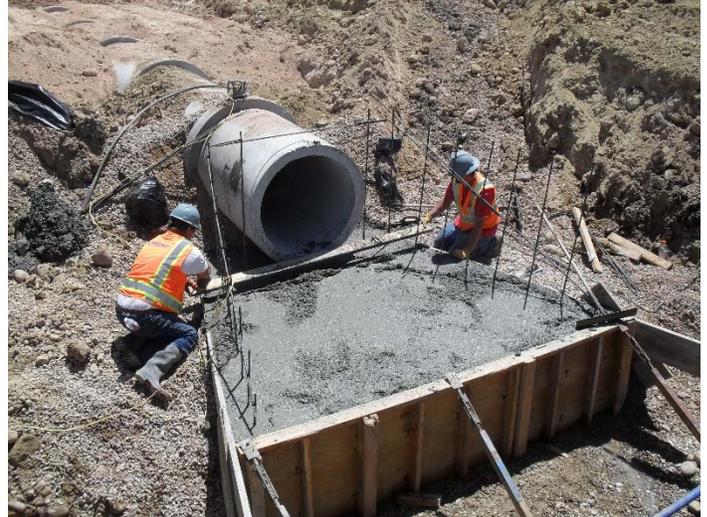
Pouring SD-B headwall (5/24)

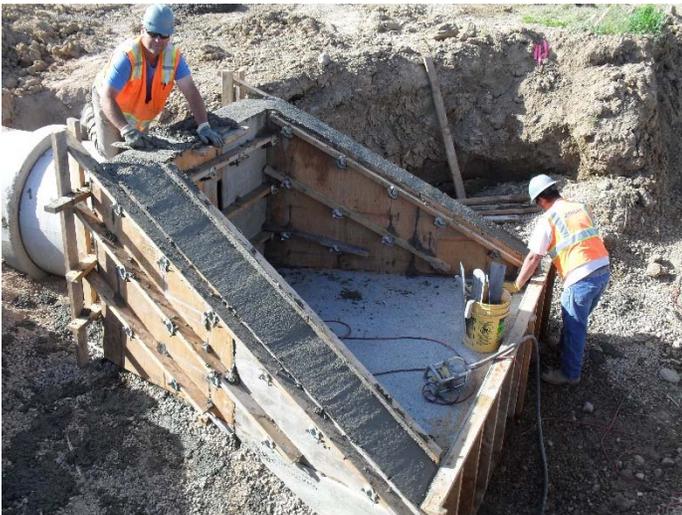
Pouring SD-B headwall (5/25)

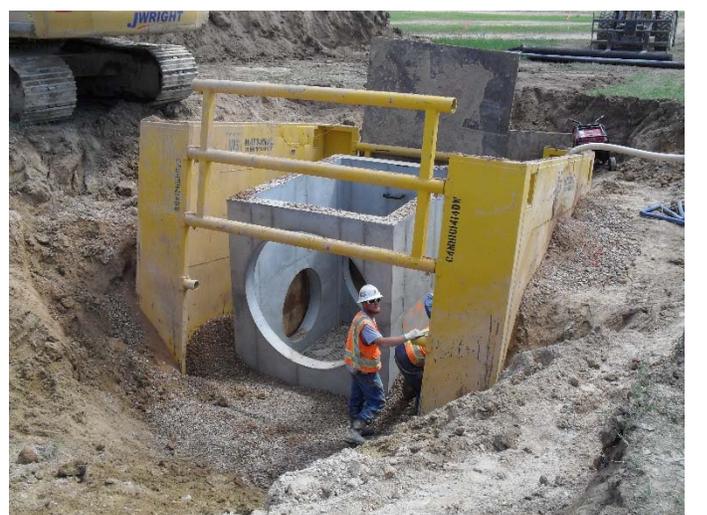
Setting MH SD-A1 (5/25)

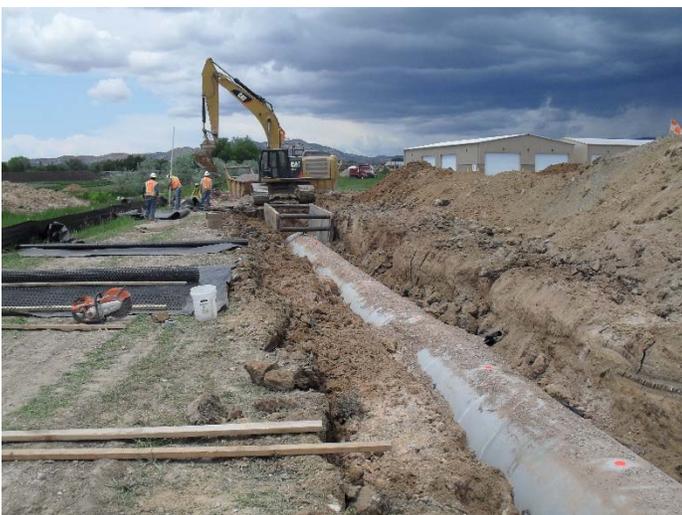
Placing 54" for SD-A (5/26)

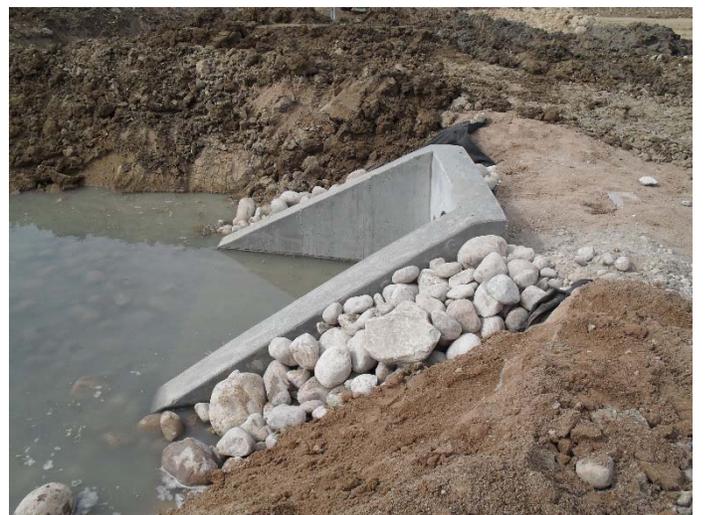
Headwall and rip rap for SD-C (5/26)

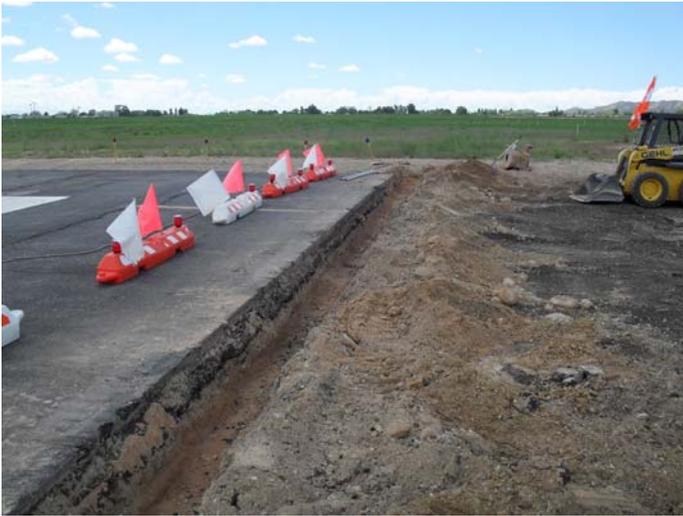
Placing conduit under connector A5 (5/27)

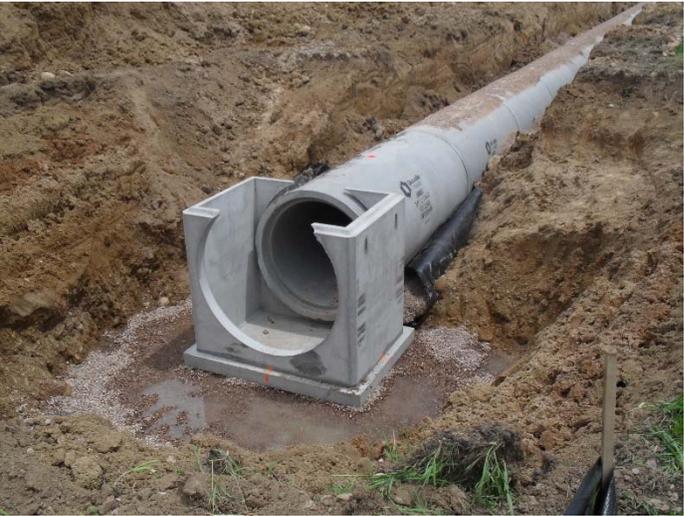
Placing MH for SD-A (5/27)
